AUSTRALIAN ATOMIC ENERGY COMMISSION
RESEARCH ESTABLISHMENT
LUCAS HEIGHTS

ACOUSTIC EMISSION MONITORING OF A STEEL BIFURCATE
AT DARTMOUTH DAM

February 1978

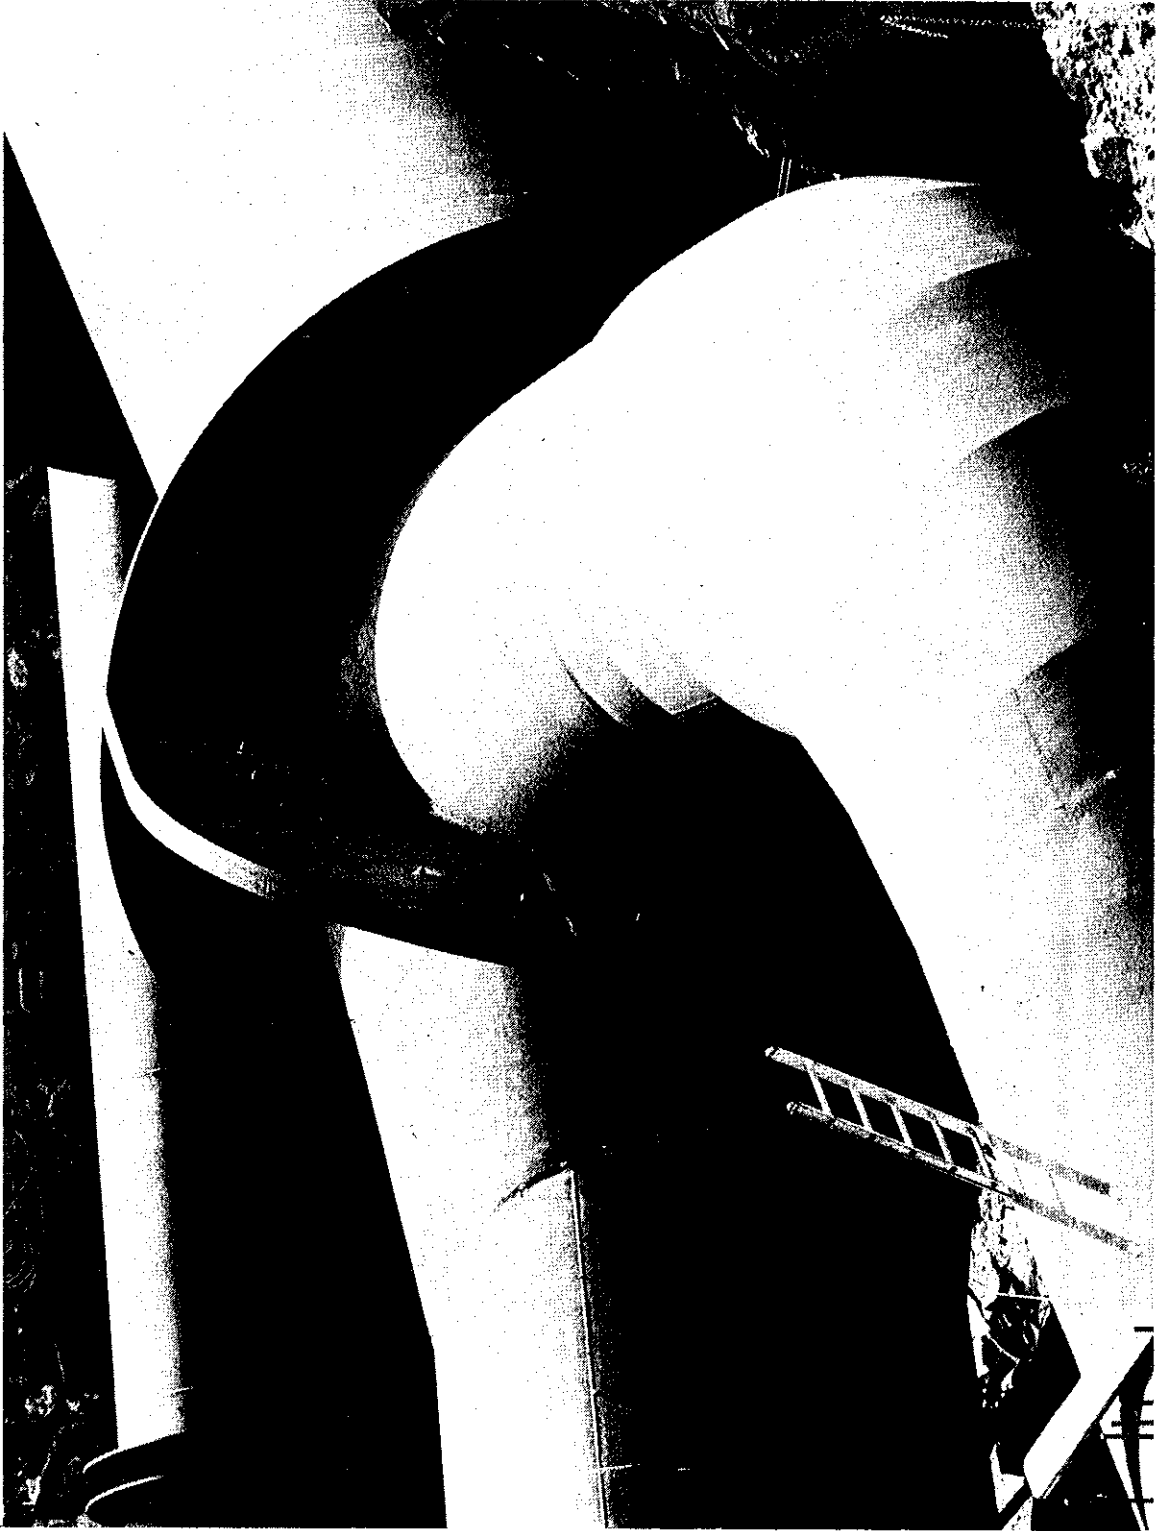
FIGURE 2. BIFURCATE D9. VIEW FROM ABOVE SHOWING REINFORCING RING GIRDERS

Although they were of advanced design, only bifurcate D9 gave any significant fabrication problems. Distortion due to welding and fitting-up stresses produced a flat spot on the top of the main upstream section of D9, and required the building up of a circumferential weld on the downstream, right-hand branch. Because of these problems it was decided that D9 would be extensively strain gauged during proof testing and, as a further assurance of safety, AE monitoring would be carried out.

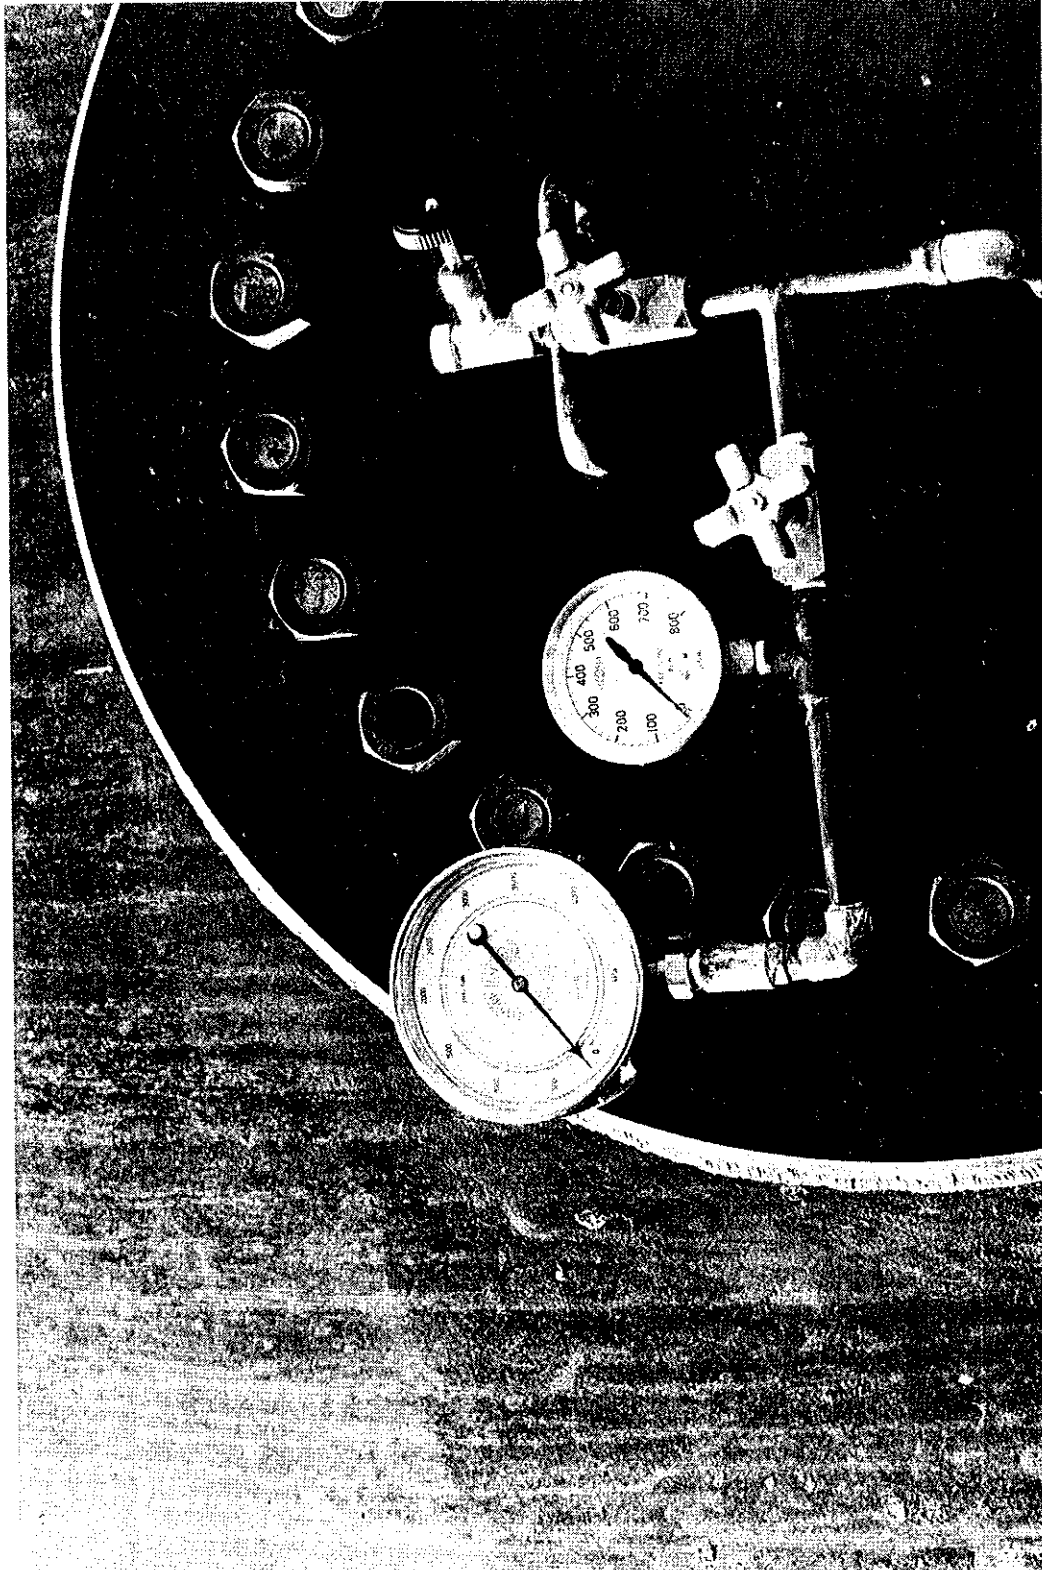
PLAN VIEW

The two bifurcates (D1 and 9) and the pipe section shown in Figure 1 were filled with water and pressurised using a four-stage positive displacement pump. Dial gauges were placed on a manifold at the lower blanked-off end (Figure 5). Pressurisations were carried out in three cycles to the proof test pressure of 3320 kPa. The pressure was reduced to ~ 650 kPa between each cycle. During each pressurisation, pumping stopped for ~ 15 min every 650 kPa to permit SMEC personnel to record strain gauge readings.

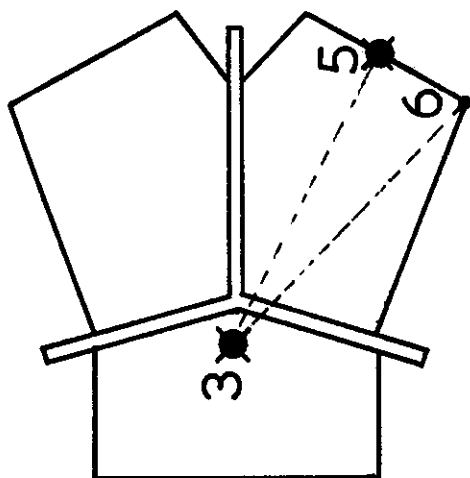
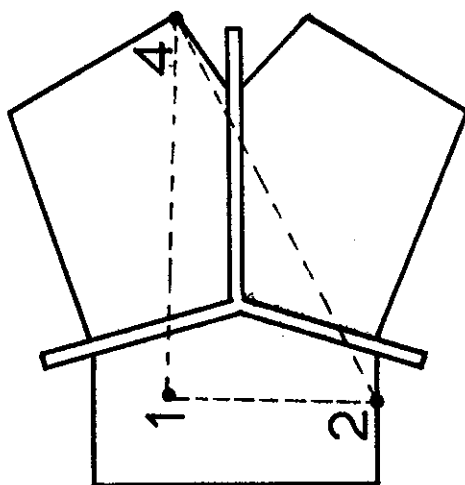
The AE transducer outputs were divided into two channels, representing two different monitored triangular areas on the bifurcate (Figures 6 and 7). Because the computer could monitor only one area at a time, switching was provided through co-axial relays.

These triangles were set up specifically to monitor the flat spot on top of the main pipe (Circuit A) and the circumferential weld on the right-hand branch (Circuit B); however, the sensor placement was also made to obtain the maximum coverage of the rest of the bifurcate.

At all stages of testing, AE sources were recorded in both of the triangular areas monitored; however at no stage of the testing was any localised repetitive source detected, indicating that no plastic deformation was occurring in any monitored area.

FIGURE 6. LOCATION OF TRANSDUCERS ON BIFURCATE D9. The six numbered transducers were divided into two circuits A & B to monitor two separate triangular areas. Note that the dotted lines are guides only and do not represent the projection of the sides of these triangles.

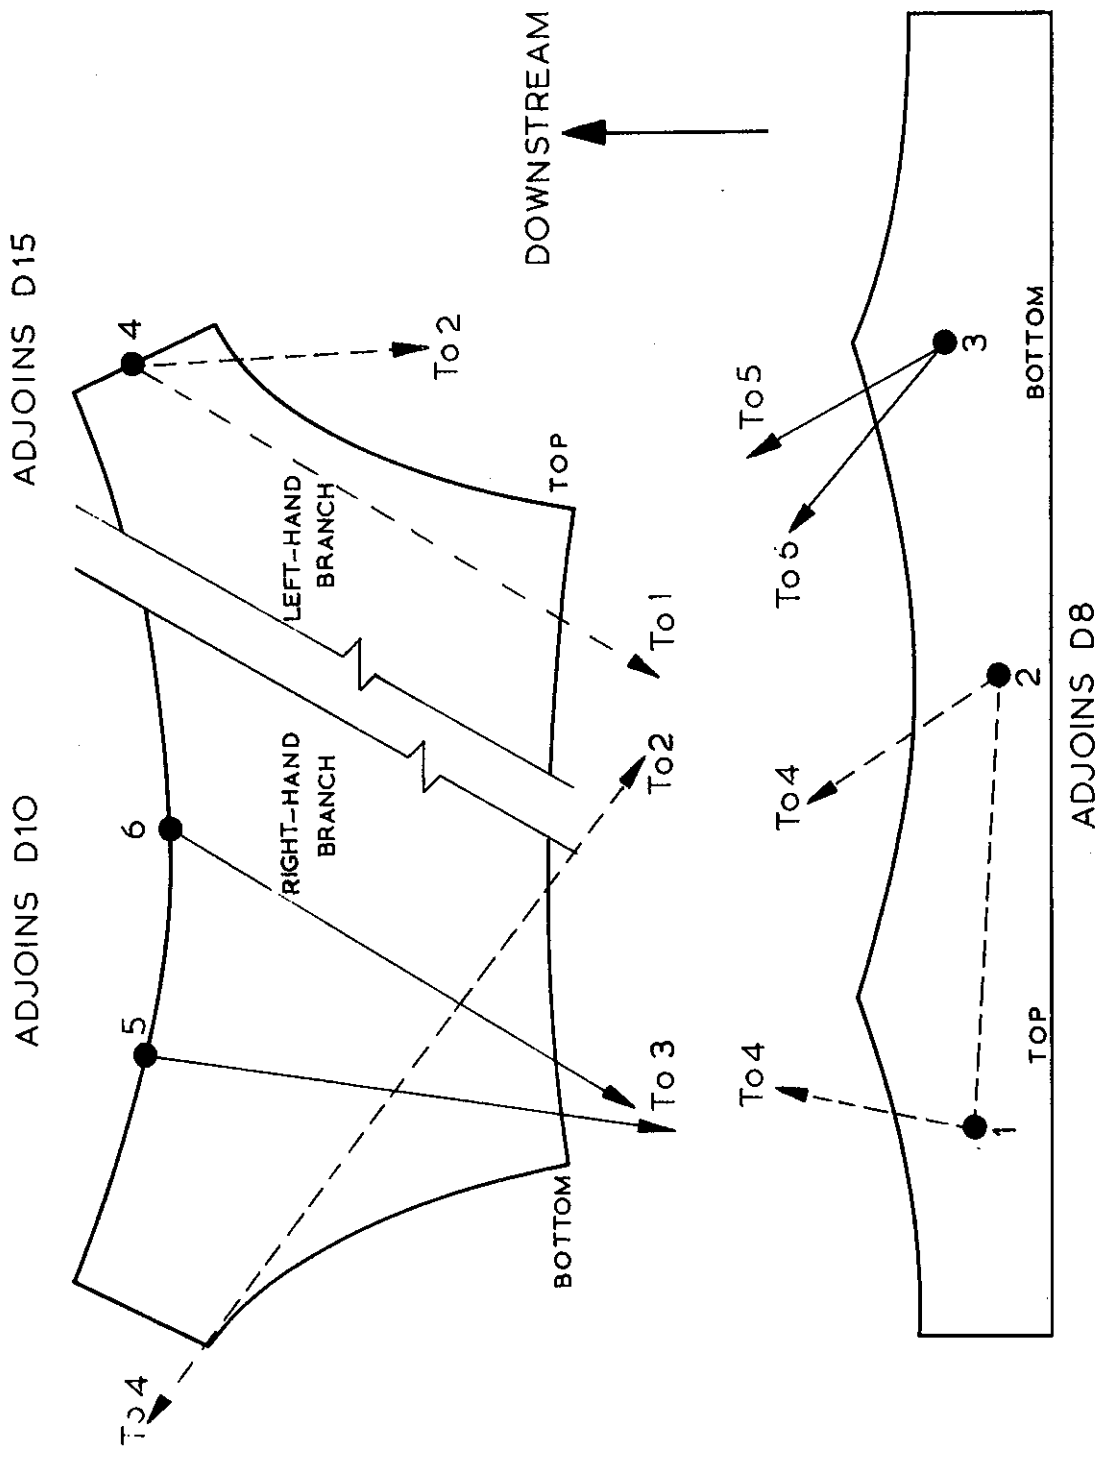
FIGURE 7. UNFOLDED SHELL OF BIFURCATE D9 SHOWING THE SIDES OF THE TWO TRIANGULAR AREAS MONITORED BY FLIC 3. (CIRCUIT A - DASHED LINES)

The AAEC mobile AE laboratory, a caravan, was towed to ~ 30 metres from the bifurcate. Coaxial leads were connected through preamplifiers to six AE transducers attached to the bifurcate, in the positions shown in Figures 6 and 7. An additional transducer, an accelerometer, was also attached to record the audiofrequency component of the emissions and to monitor extraneous noises. Because the acoustic waves detected by the transducers travel within only the steel shell and do not enter the water, the 'unfolded' shell of the bifurcate (Figure 7) is used to determine the sound paths in the structure.

Although AE testing is still in its infancy and cannot be used to guarantee the integrity of a structure, it seems unlikely that any significant defect grew during the proof test, or that any yielding occurred. No AE from yielding was detected around the flat spot on top of the main inlet branch of the bifurcate, and none was detected near the circumferential weld on the right-hand branch. These results confirm earlier weld radiography and concurrent strain gauge monitoring. Verbal reports from SMEC personnel at the time of the test suggest that none of the strain gauges on the bifurcate detected any yielding.
