**AUSTRALIAN ATOMIC ENERGY COMMISSION  
RESEARCH ESTABLISHMENT  
LUCAS HEIGHTS**

**ACOUSTIC EMISSION MONITORING OF A STEAM  
RECEIVER PRESSURISED TO FAILURE**

April 1978

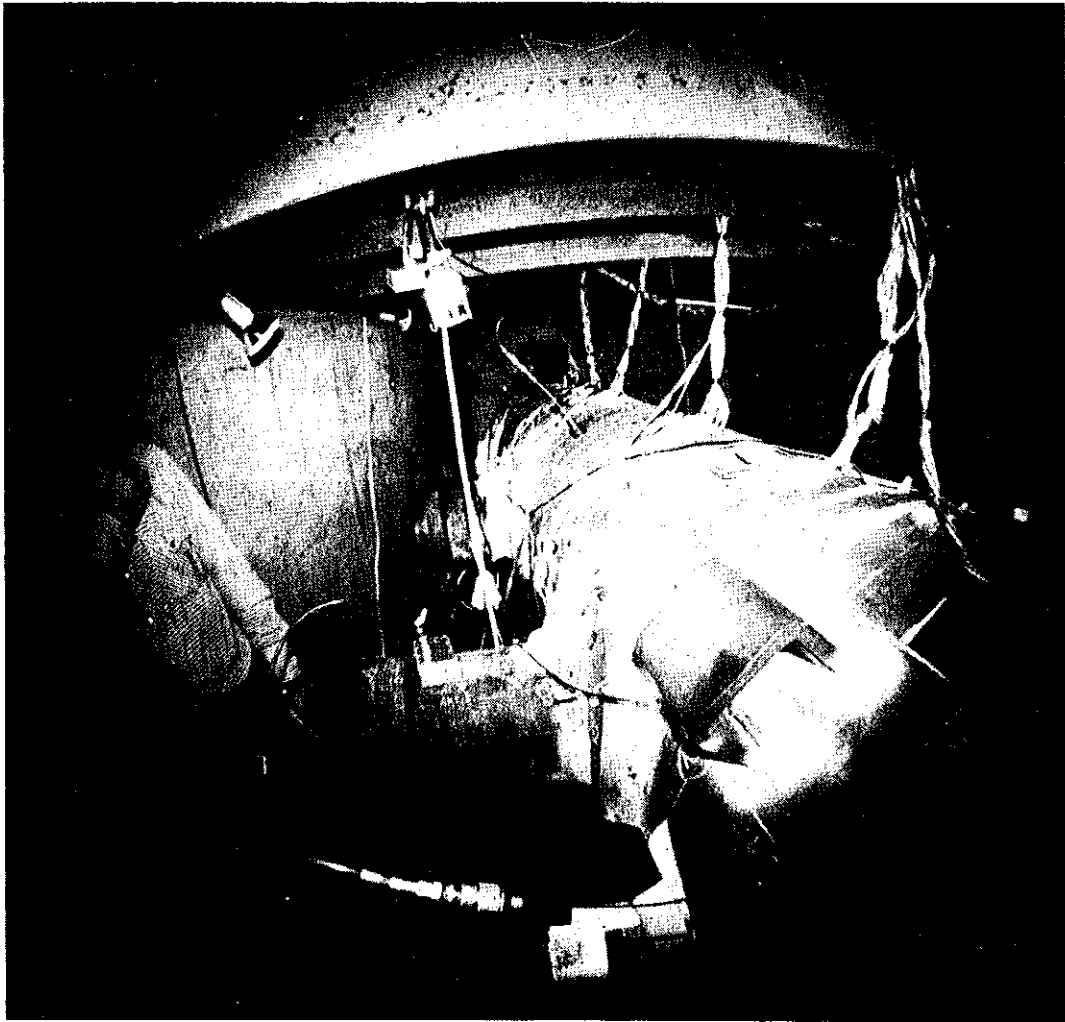
The vessel was in service for approximately ten years and was operated at a nominal pressure of 9.6 MPa (1400 psi) at 550°C. The defects causing its removal from service were extensive cracks in the vessel adjacent to all nozzle reinforcements. These cracks ran circumferentially around the nozzle penetration, and those on the inside surface of the vessel were up to 25 mm deep.

Figure 2 Photograph of the vessel in the bunker. (The apparent distortion results from the use of a fisheye lens. The person's left hand is close to nozzle 2. Nozzles 3 and 4 can be seen further from the camera.)

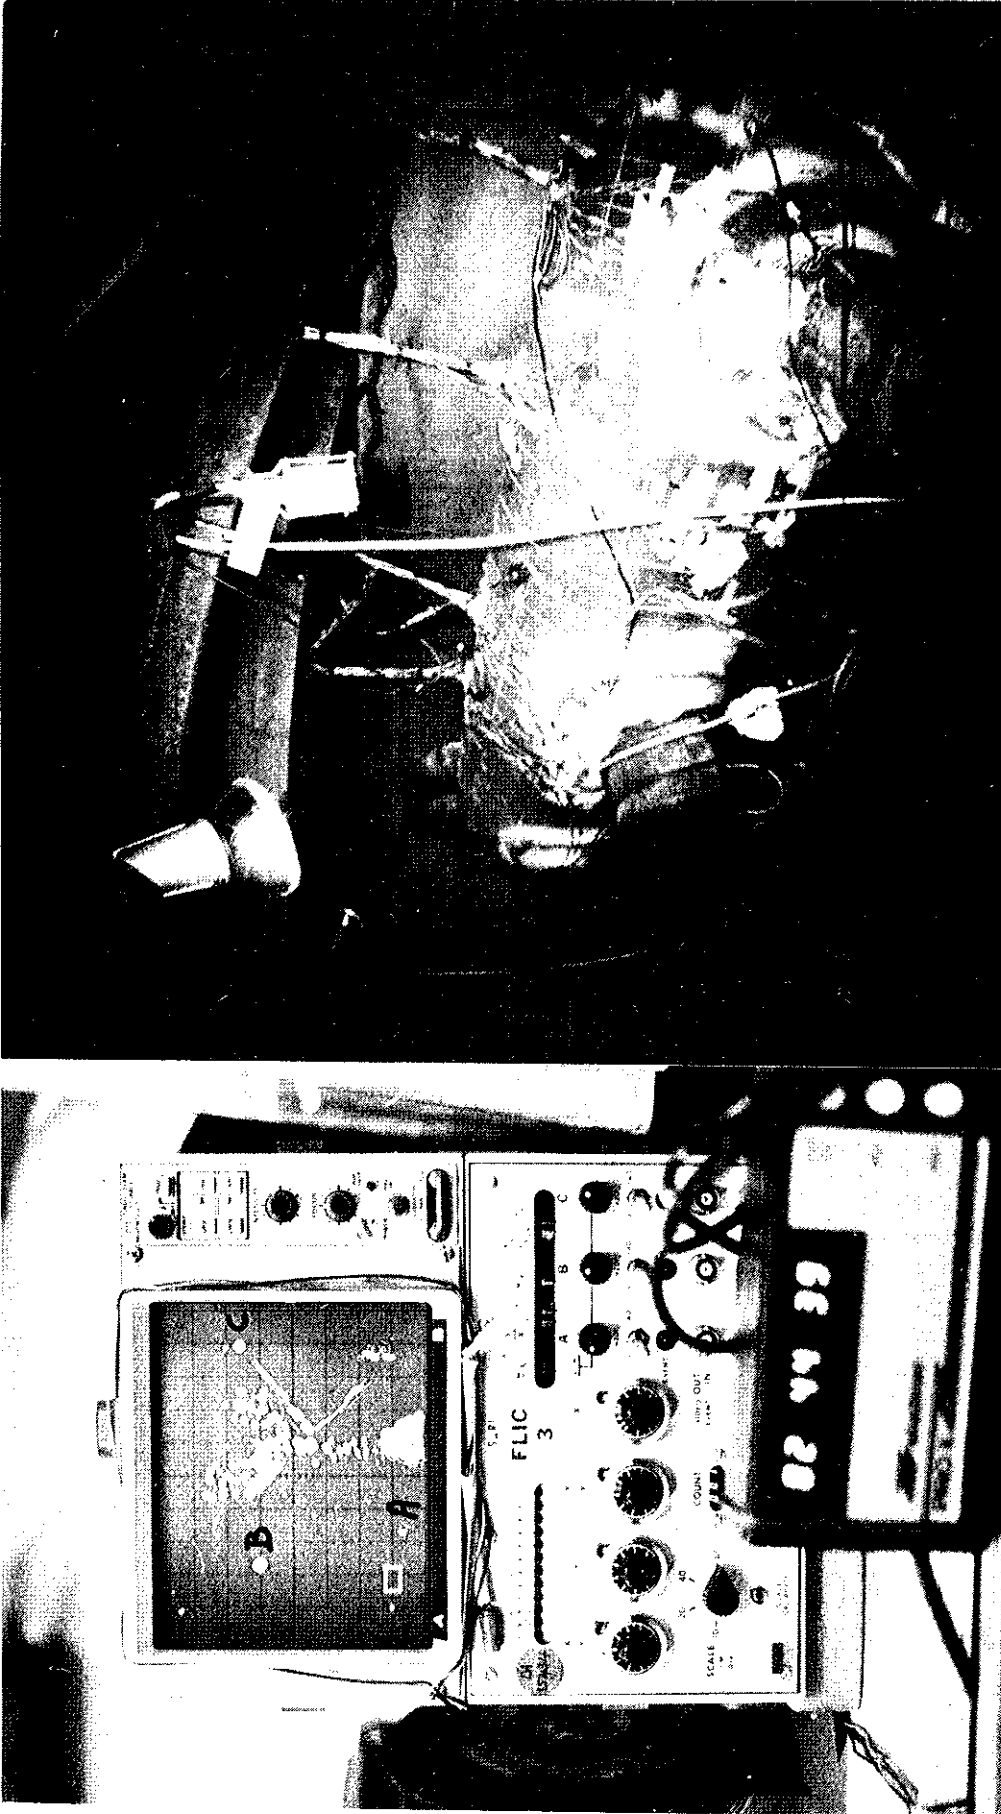
The AE activity in the region monitored by the FLIC unit, showed a distinguishable pattern of events (Figure 8). Nozzle 2 gave copious amounts of AE distributed generally around the nozzle penetration. This activity outlined the position of the nozzle reinforcement on the FLIC screen; however, the image was distorted owing to the interference of the hole made in the vessel shell by the nozzle. This hole blocked the direct sound paths from sources on the side of the nozzle opposite any one of the location transducers. A large amount of AE was observed at a very localised position on the underside of nozzle 3 and only just within the monitored area. At this stage, the emission detected within the area monitored by the FLIC unit comprised the majority of the emission detected from the entire vessel.

Figure 5 Typical composite video picture. (The transducer positions have been identified on the screens of FLIC and are as shown in Figure 4. The reinforcement of nozzle 2 has been delineated by acoustic activity and a high proportion of emission sources is evident adjacent to nozzle 3.)

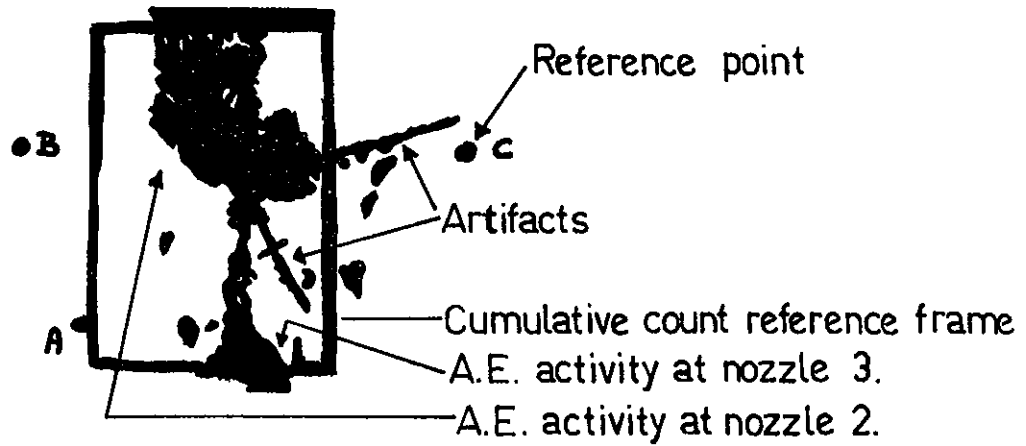
The time history of the final four cycles is given in Figure 7. As the pressurising pump was near the limit of its performance, there were breaks in the program to allow pump repairs to be carried out. A great deal of AE in the vessel was evident during all pressurisation cycles, but much more arose from such phenomena as the motion of the vessel on its supports and the bedding of the manhole cover on its seal. Much of this activity produced artefacts within the monitored triangular area. Artefacts are apparent activity within the monitored area which result from AE events which are well outside the area. Most artefacts are easily recognised as they appear as straight lines emanating from the centroid of the triangle defined by the FLIC sensors. Figure 8 is an annotated reproduction of the FLIC display, and the artefacts are indicated.

Figure 8 Annotated reproduction of FLIC display. (The geometry is the same as that in Figure 4.)

It should be cautioned that, in this study, a large flaw may have escaped detection if it caused failure at a low pressure when artefact activity was high. For similar tests it is clear that more care is needed in the provision of silent supports and the seating of flanges and access ports.

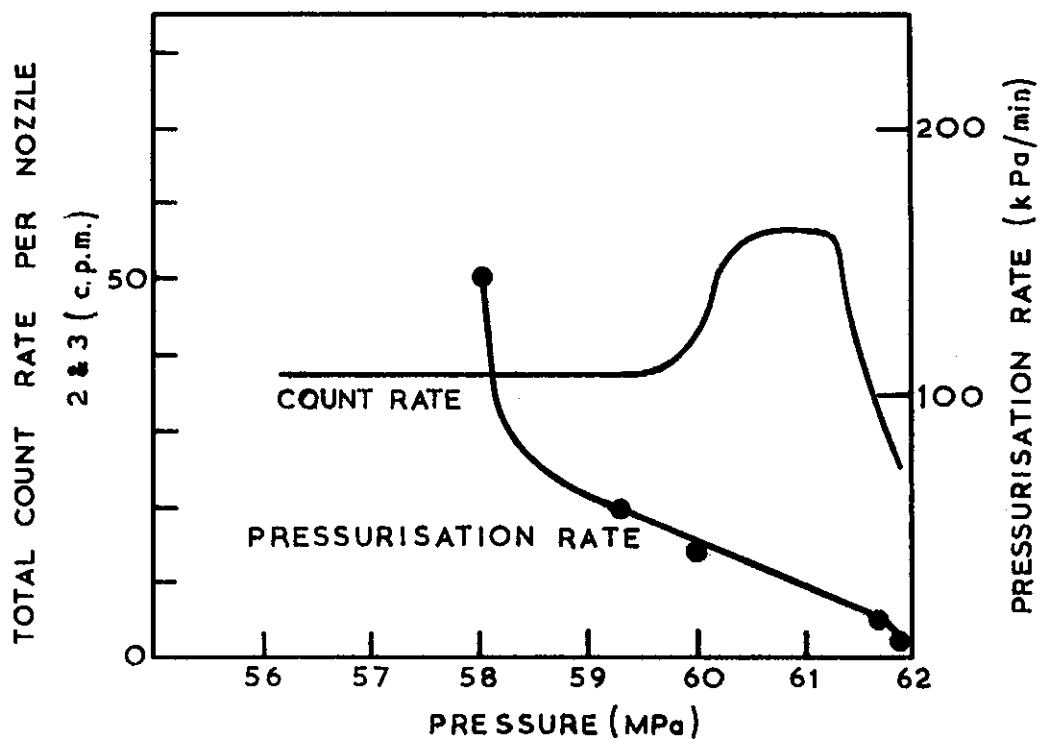
In the later stages of the final pressurisation, the AE activity finally decreased, possibly because of reduced pumping rate (Figure 9); however, the relative proportion of the activity at the nozzle 3 location tended to increase and become more localised. A quantitative picture of the distribution of AE activity between nozzles 2 and 3, as seen by FLIC, is given in Figure 10. The activity at nozzle 3 suggested a higher strain concentration and therefore implied that this position was the most likely initiation point for the final fracture of the vessel. The vessel finally failed at 62.1 MPa (9000 psi) with no increase in AE activity before failure. The lack of an AE warning of imminent failure is typical of materials behaving in a ductile manner [Birchon 1976; and also see Figure 3].

Figure 9 Acoustic emission and pumping rate history during the final stages of pressurisation.

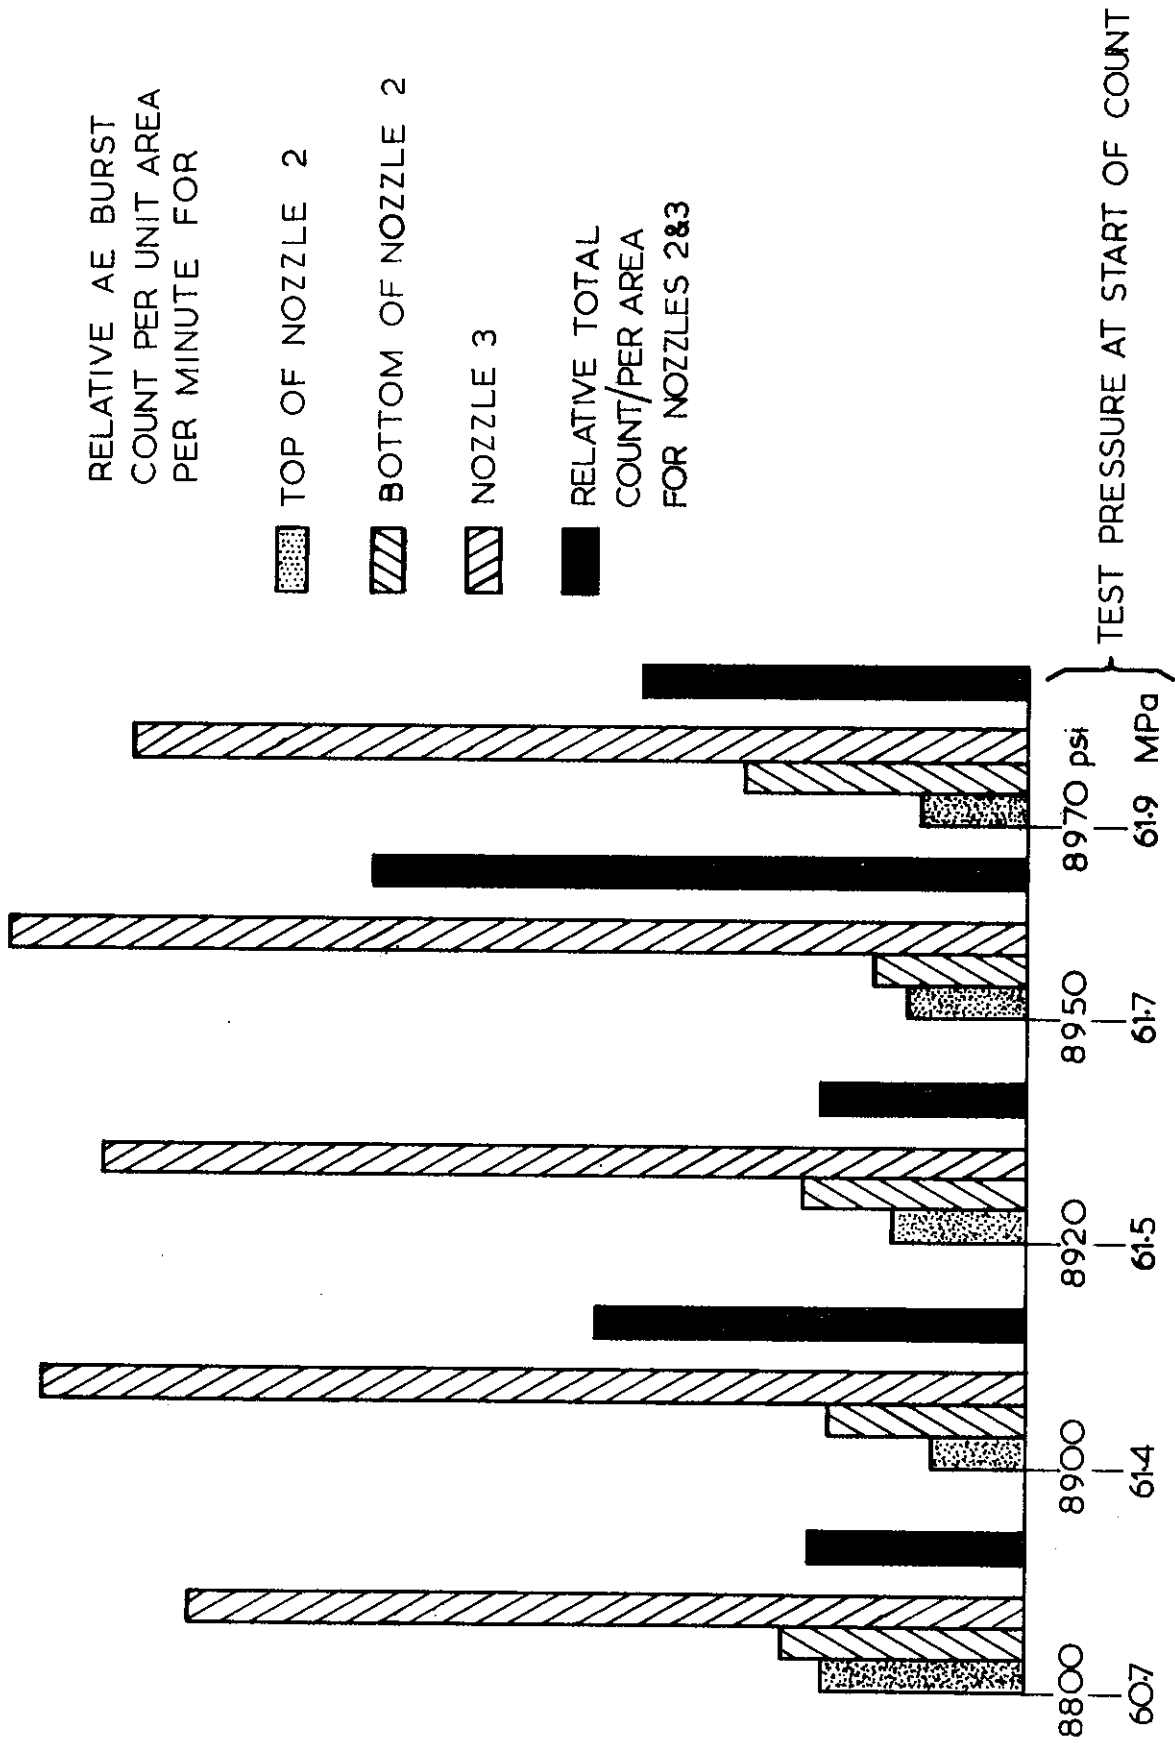
Figure 10 Distribution of AE activity between nozzles 2 and 3 as a function of time.

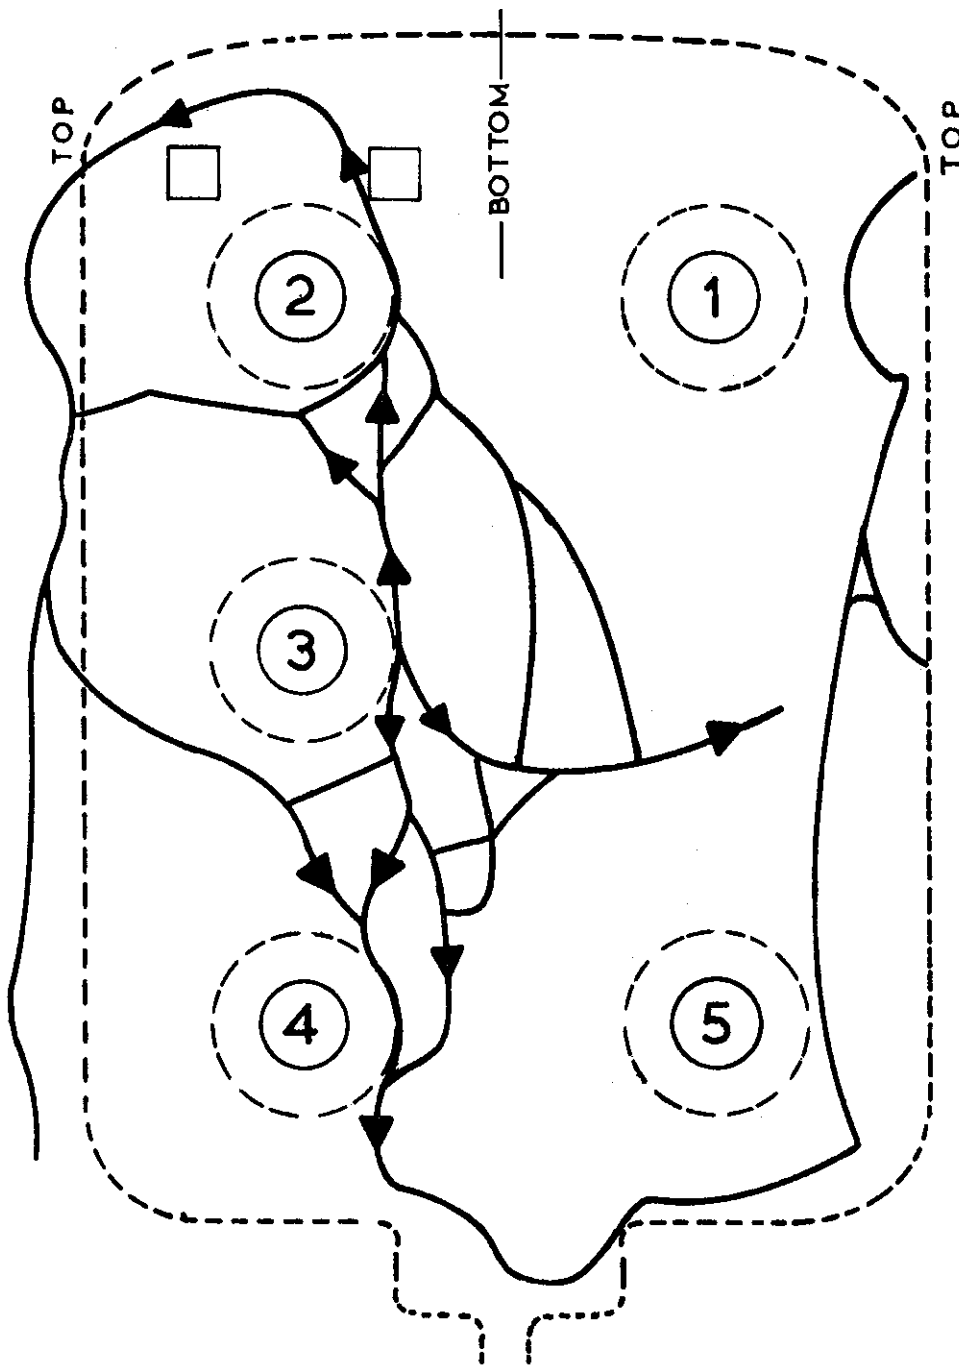
The fractography of the broken surface of the fragments suggested a number of possible sites for the origin of the initial fracture. A group of experts (members of AWRA Project Panel 1) concluded, from a fractographic examination, that a location under nozzle 3 was the primary initiation point. This point was coincident with the area of highest AE activity during the later stages of pressurisation.

The failure appeared to propagate axially along the vessel from this point, then to branch circumferentially between the nozzles. Nozzles 2, 3 and 4 then lifted and separated, causing an axial fracture diametrically opposite the underside of these nozzles. This fracture acted as a hinge which allowed the three nozzles to lift. The only evidence of ductile fracture was in a narrow shear lip adjacent to the external surface of the vessel and along this 'hinge'.

Figure 12 Development of the vessel showing the fracture paths and directions of crack propagation deduced from the fractography. (The nozzles are identified and the transducers used for location are denoted A, B and C.)
