A Review of Australian Investigations on Aeronautical Fatigue and
Structural Integrity During the Period April 2017 to March 2019

Aerospace Division
Defence Science and Technology Group

DST-Group-TR-3634

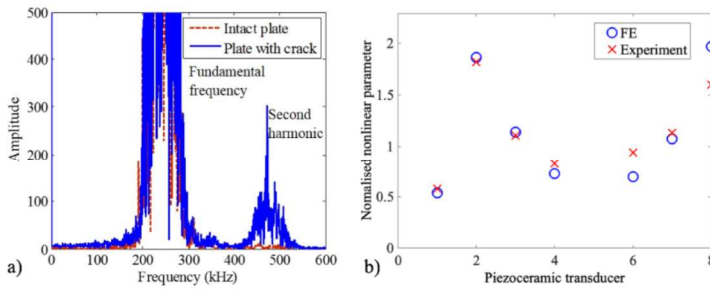
Figure 1a) Experimentally measured signal for incident S_0 guided wave, b) comparison of 3D FE simulations and experimental results [2].

Figure 1a, for example, shows the spectra of the experimentally measured signal for the incident S_0 of Lamb waves. The experimental results indicate that there is a relatively large (with respect to the detection by common PZT sensors) magnitude of the second-order harmonic induced by the interaction of the incident wave signal with a fatigue crack. Figure 1b shows a comparison of 3D finite element (FE) simulations with the experimental data. The comparison demonstrates a good agreement; and it confirms, in particular, that

the experimental guided wave studies can be ultimately replicated with high-fidelity numerical simulations.

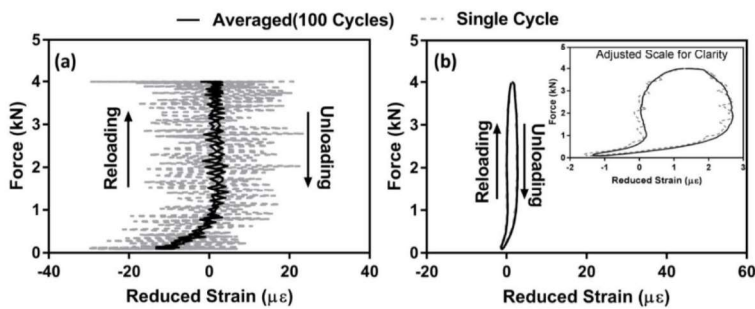
Figure 1. Reduced strain measurements at block 282 where the dashed line is a single cycle and the solid line is averaged over 100 cycles for a) resistive strain gauge and b) piezoelectric strain gauge

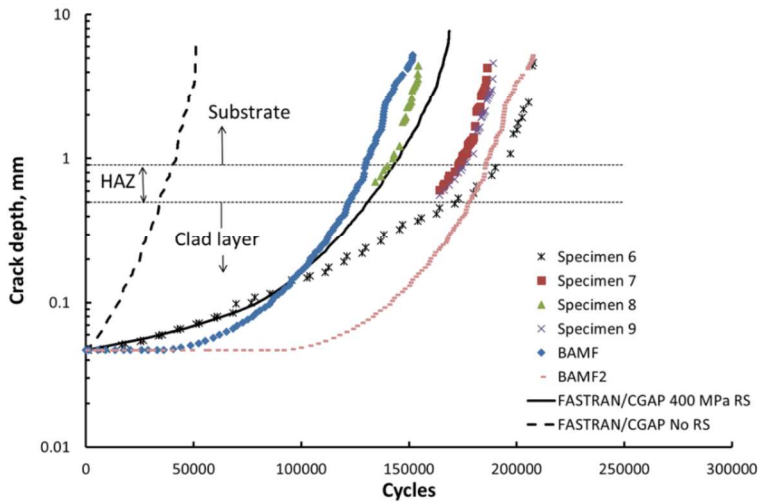
Figure 1. Modelling results for crack propagation through compressive residual stress field in case of laser cladding repair of AerMet®100 steel

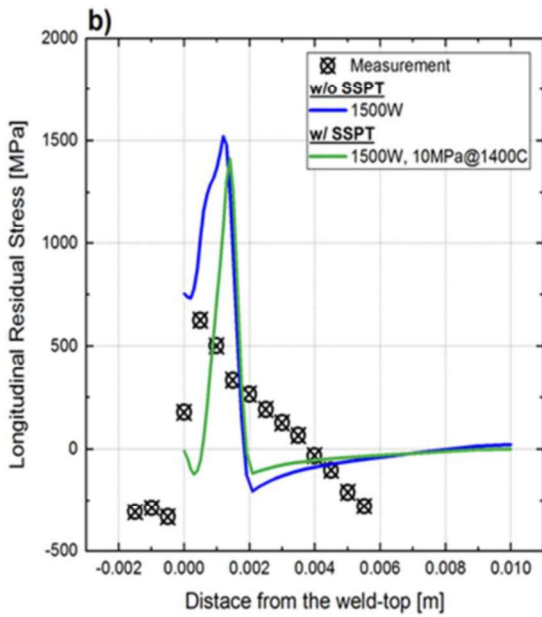
Figure 2. Residual stress profile comparisons, with and without SSPT

The work has progressed to also develop modelling of the residual stress field [2]. The residual stress field modelling is extremely complex. It involves accounting for constrained thermal expansion and plasticity, and also non-linear Solid State Phase Transformation (SSPT) effect which occur for martensitic steels such as AerMet®100, 300M and AISI4340. Early attempts to model the process without including the SSPT resulted in significant error, including predicting tension at the surface instead of compression. Preliminary results with 4340 steel including the SSPT effect are encouraging, as shown in Figure 2. Further work is ongoing to include important details in the modelling including material addition and overlapping tracks with subsequent re-heat effects.

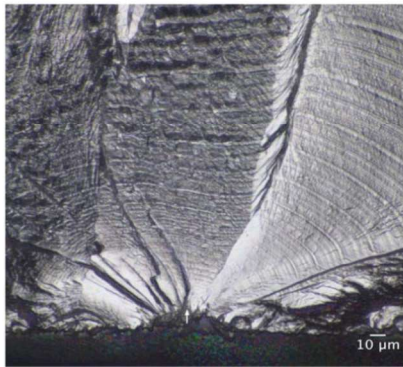
Figure 1. Crack surface

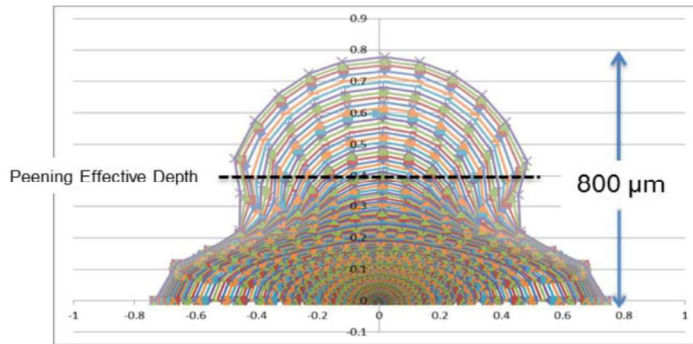
Figure 3. BAMF model after growth through the shot peen RS field

The analyst can include the effect of a known residual stress condition such as shot peening. This can cause the crack to adopt an unusual shape, see Figure 3 for example for the case with shot peening. The results in terms of crack size against simulated flight hours for with and without shot peening cases is shown in Figure 4. Further details are available at [2].

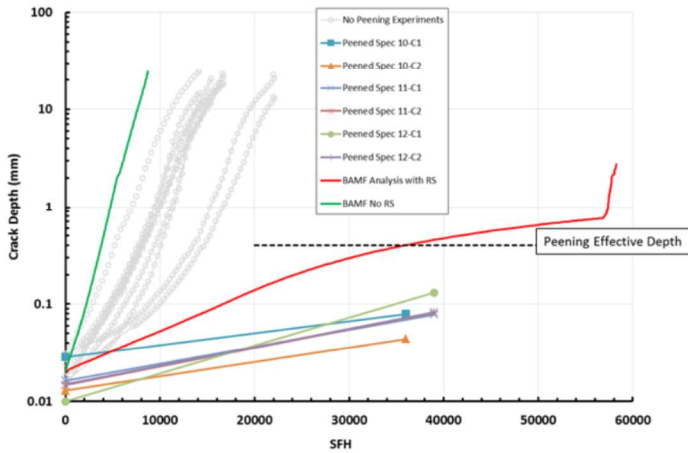
Figure 4. Crack growth predictions vs experiment for with and without shot peening

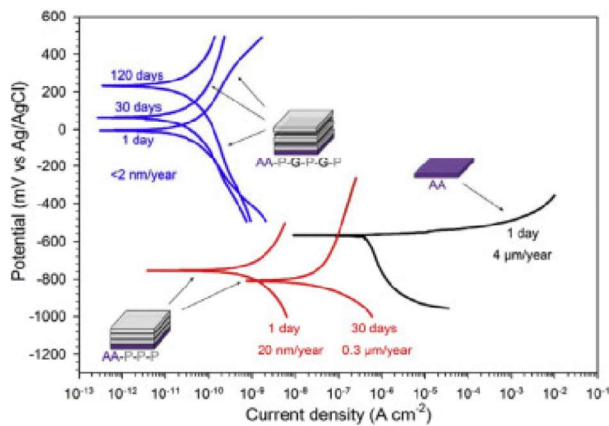
Figure 1. Potentiodynamic scans for various exposure times in NaCl solution

Numerous studies on the electrochemical behaviour of these coatings have shown improved corrosion performance. Most recently, Hybrid coatings based on CVD, comprising two single layers of CVD graphene sandwiched by three layers of polyvinyl butyral, (P) provide complete corrosion protection of a commercial aluminium alloy (AA) up to 120 days of exposure to simulated seawater (Figure 1).

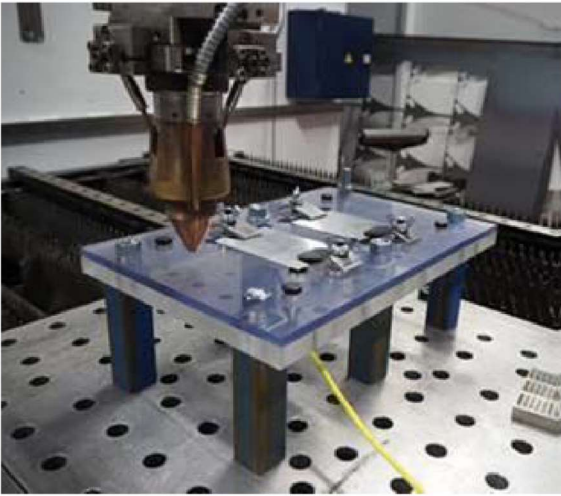
Figure 1. Test Samples Mounted in the RMIT Trumpf Laser

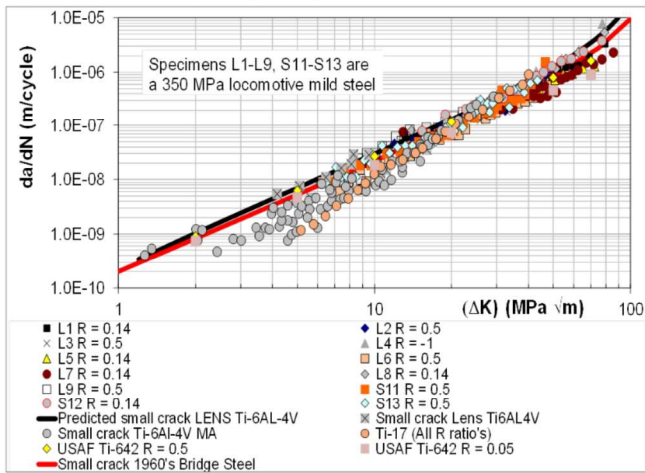
Figure 2. Comparison of crack growth rate data for some Conventionally Manufactured Materials as well as various AM repaired specimens using LAD and Cold Spray (SPD)

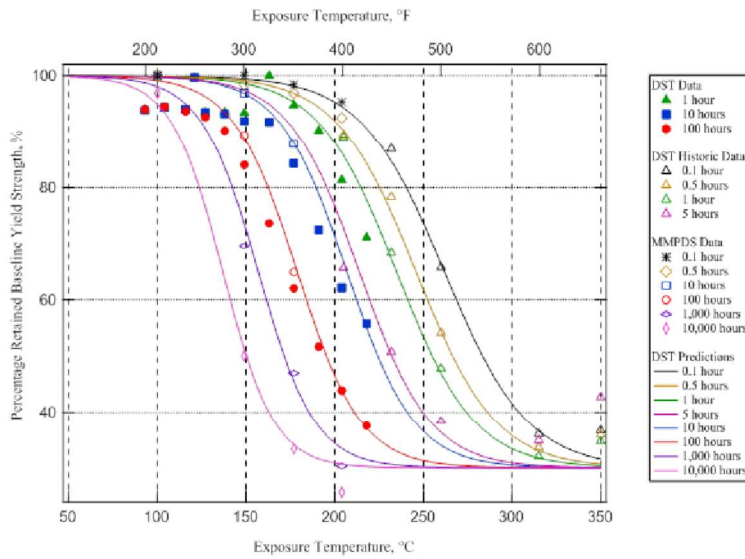
Figure 1. DST Group retained strength model predictions for AA7050 tested against independent data

exposure times ranging from 10 minutes to 10,000 hours for AA7050, and exposure times ranging from 10 minutes to 100 hours for AA7085. The average percentage error for this model was 2.9%, with a maximum error of 12.9%.

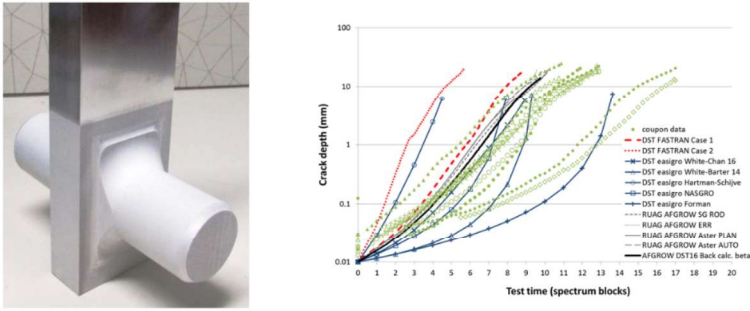
Figure 1. Fatigue test specimen and combined results [2] from first challenge – combat aircraft wing root shear tie (full details can be found on www.govteams.gov.au)

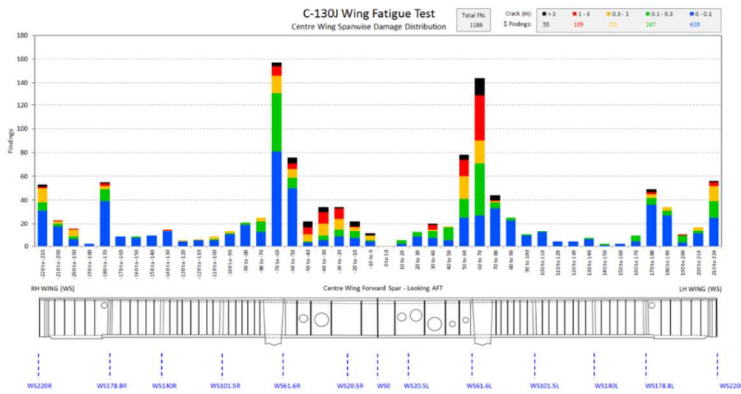
Figure 1. C-130J Wing Fatigue Test teardown centre wing span-wise damage distribution map

The teardown phase of the program, an activity recommended by [1], recorded in excess of fourteen hundred discrete damage findings. The most significant of these were selected for forensic analyses to provide valuable crack growth data for test interpretation activities. Figure 1 presents a span-wise distribution of some of the damage found during teardown in the centre wing structure.

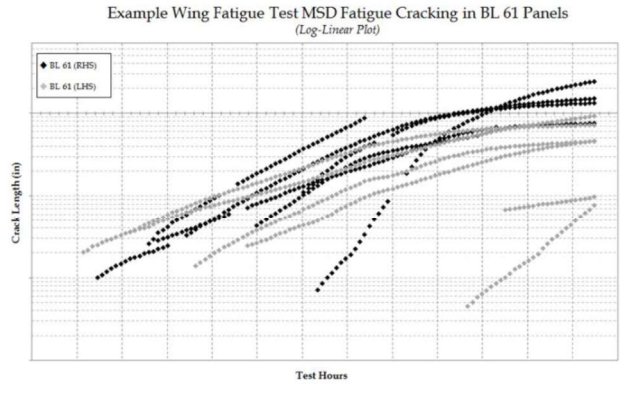
Figure 3. Indicative log-linear crack growth curves determined from QF that underpin Test Interpretation activities

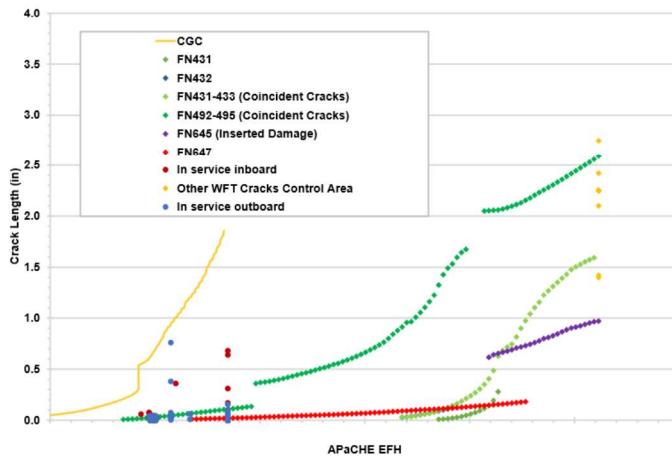
Figure 1. Crack growth modelling versus test cracking and fleet observations

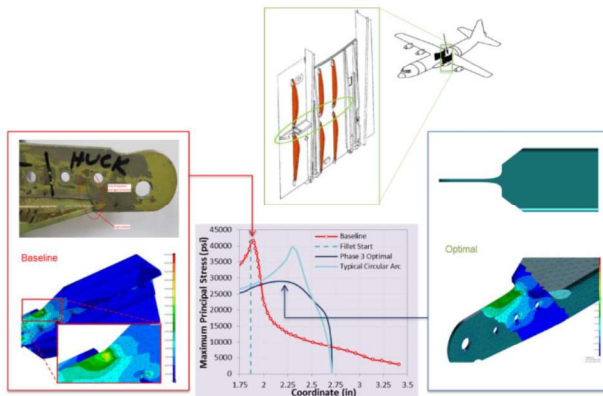
Figure 2. Application of the hypotrochoid-based approach for the design of optimal rework shape of C-130J bow beam runout.

Both applications showed that the hypotrochoid-based optimal design approach is readily transferrable for broader applications.

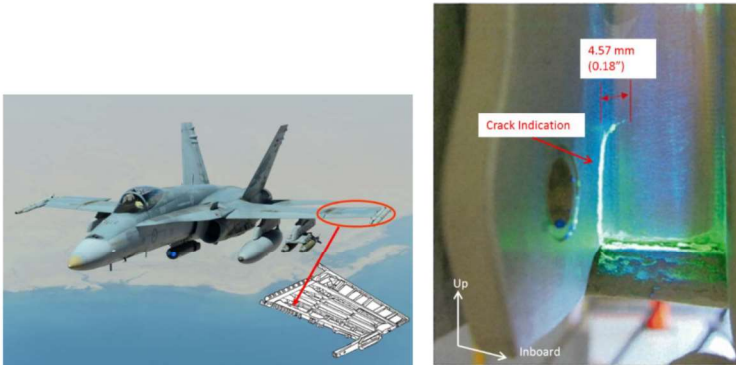
Figure 1. The outer wing of the F/A-18A/B Hornet with the location of the OLEF Hinge Lugs marked (left) and (right) liquid penetrant indications of fatigue crack growth from an in-service outer wing exhibiting MID.

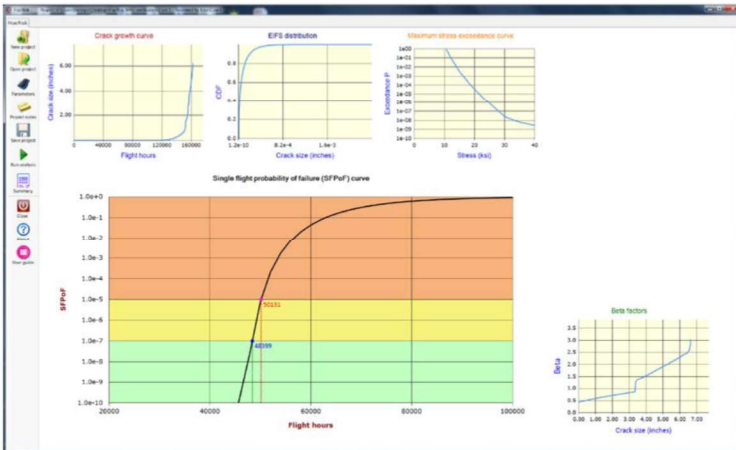
Figure. 3 FracRisk graphical user interface

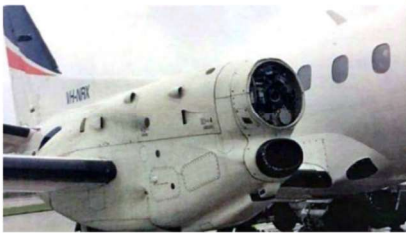
Figure 1. View of the aircraft after landing

On 17 March 2017 a Regional Express Saab 340B aircraft registered VH-NRX was forced to make an emergency landing after the right propeller departed mid-air Figure 1. The propeller was found a few days later in bushland in Sydney's south-west, Figure 2. In its preliminary report, the Australian Transportation Safety Board (ATSB) stated that a fatigue crack had formed in the propeller mounting flange, where the propeller attaches to the gearbox, and transitioned into the shaft section. The crack originated at the bore of a dowel pin near the forward face of the propeller hub flange, see Figure 4. The dowel pin bore was corroded in parts and corrosion pitting was found near the fracture. Further work is ongoing to ascertain whether the corrosion or other factors contributed to the fracture initiation.

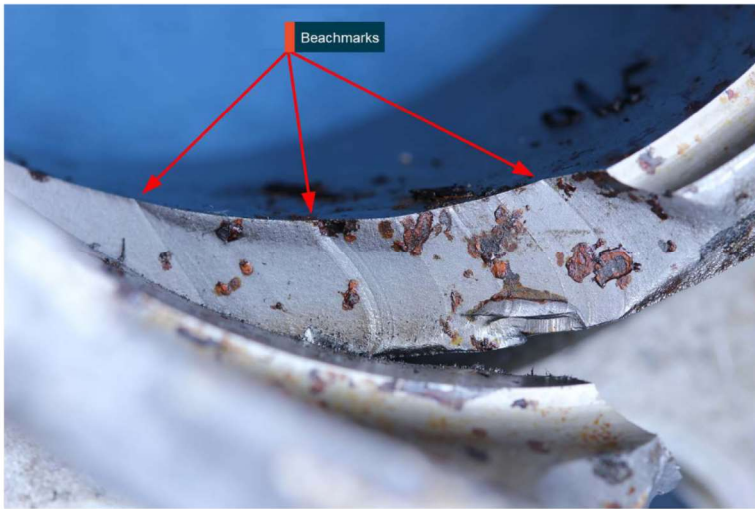
Figure 5. Image shows the progression marks on the fracture surface, which was indicative of a fatigue failure mechanism. Source: ATSB

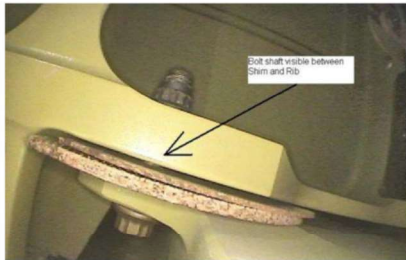
Figure 1. Bolt shaft can be seen through the gap between the shim and rib
