**AUSTRALIAN ATOMIC ENERGY COMMISSION
RESEARCH ESTABLISHMENT
LUCAS HEIGHTS**

**ACOUSTIC EMISSION AND FAILURE PREDICTION FOR
PRESSURISATION EXPERIMENTS ON HELICOPTER AIR BOTTLES**

November 1980

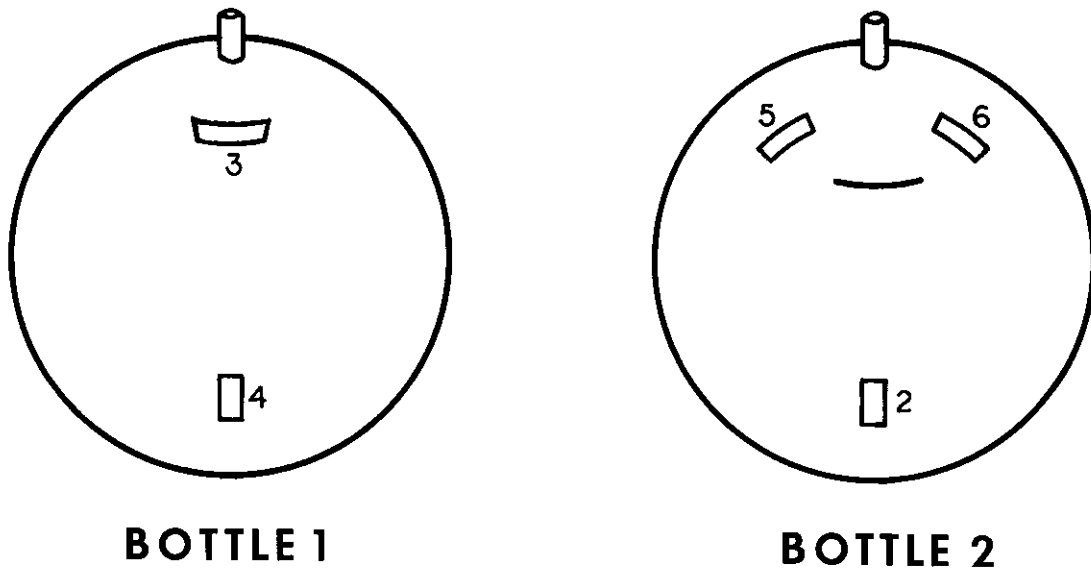
FIGURE 1. DETAILS OF STRAIN GAUGES AND DEFECTS

(a) Locations of defect and strain gauges

The welds on both bottles were examined by X- and gamma-radiography but no defects were discovered. Strain gauges were then attached to bottle 1 in the positions indicated in Figure 1. The strain gauge data and pressure instrumentation calibration are detailed in Appendix A. A single Dunegan acoustic emission sensor having a nominal resonance frequency of approximately 160 kHz was attached to the vessel which was then filled with a water and soluble oil mixture at ambient temperature (approximately 20°C), placed in a bunker, and pressurised with oil using a Dynapac hand-operated hydraulic pump. The bottle was pressurised to its proof-test pressure (34 MPa, 4950 psi); the pressure was then reduced to zero twice, before pressurisation was continued

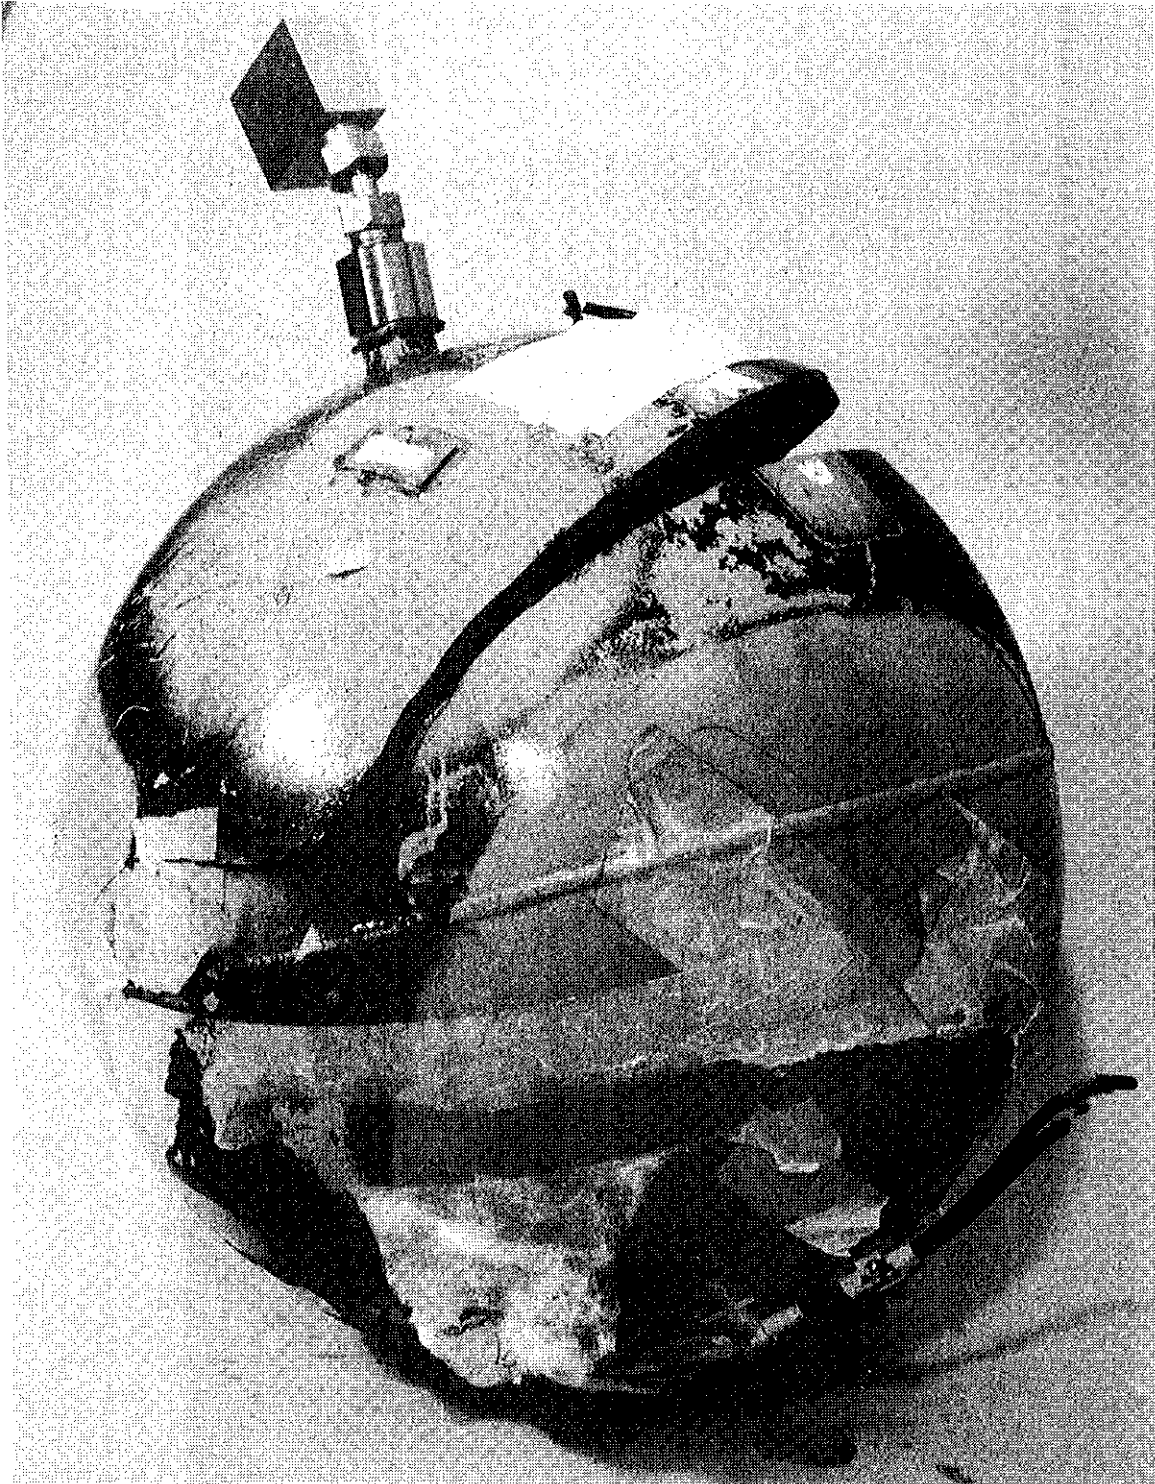
Even though hydraulic pressurisation was used, both bottles failed catastrophically. Once the fracture had been initiated, it propagated in two directions from the initiation point, and almost completely encircled the bottle allowing it to hinge open (Figures 3 to 6).

circumferential weld was noted and the fracture was not deflected when it intersected the weld; this would suggest satisfactory weld quality and structure.

FIGURE 5. BOTTLE 2 AFTER PRESSURISATION TO FAILURE

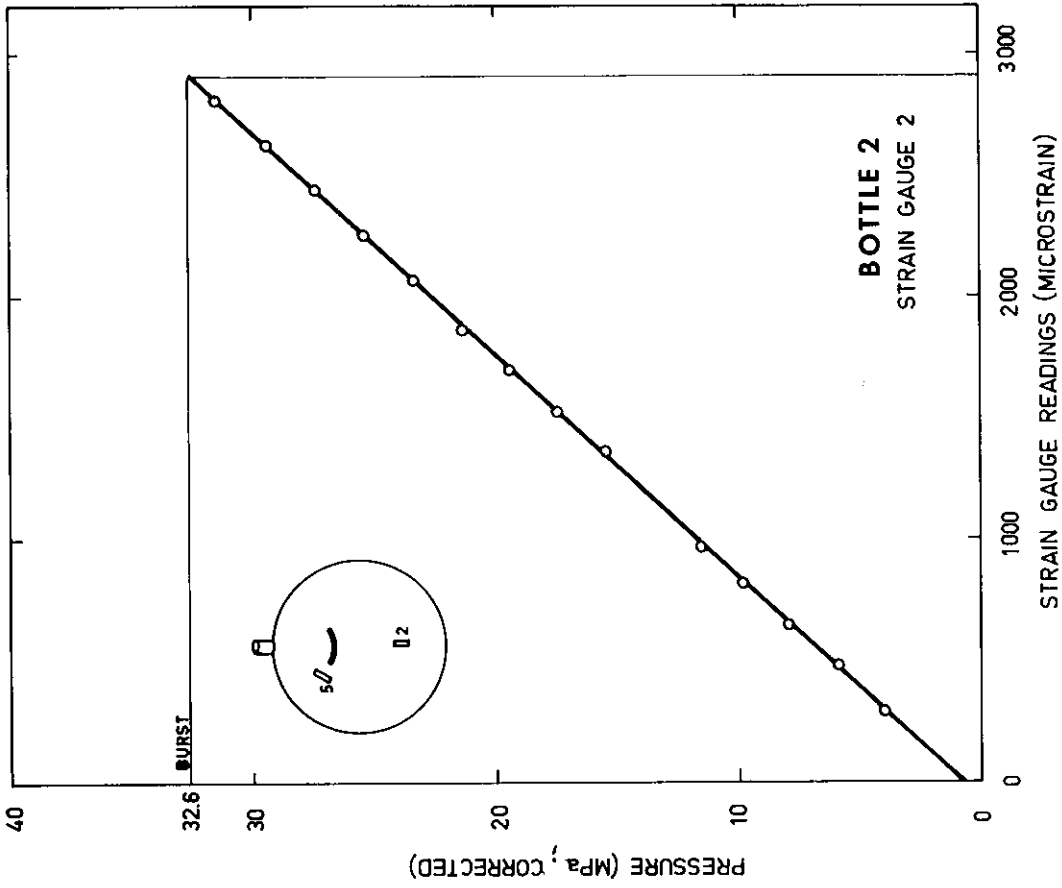
FIGURE A2. PLOT OF STRAIN AGAINST INTERNAL PRESSURE FOR BOTTLE 2

In this Appendix are shown graphically the outputs of the strain gauges attached to the air bottles. Figure A1 indicates the behaviour of a gauge on bottle 1 and Figures A2 to A4 indicate that of gauges on bottle 2. The calibration of the pressure transducer and pressure gauge is shown in Figures A5 and A6 respectively.
