**AUSTRALIAN ATOMIC ENERGY COMMISSION
RESEARCH ESTABLISHMENT
LUCAS HEIGHTS**

**A METALLOGRAPHIC STUDY OF THE STRUCTURE OF OXIDE
LAYERS ON ZIRCONIUM ALLOYS**

**E. MELLER
P.M. HEUER
D.H. BRADHURST**

November 1972

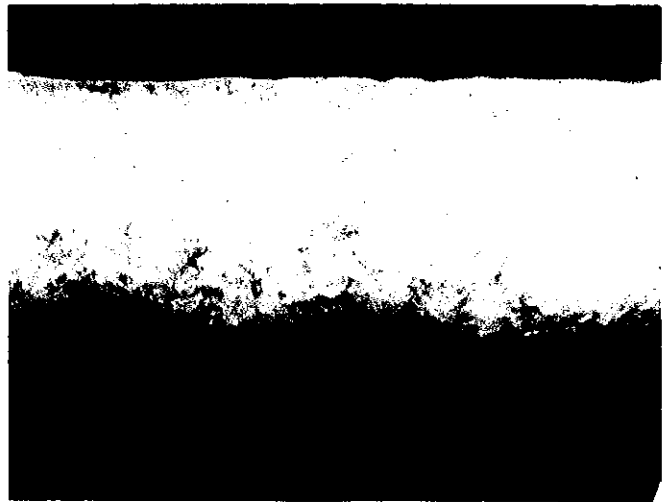
(d) appearance under polarised light

When the oxide is illuminated in the microscope under polarised light, the outer region of the oxide appears translucent (Figure 1(d)). The texture suggests a layered structure, with the innermost layers appearing in dark contrast.

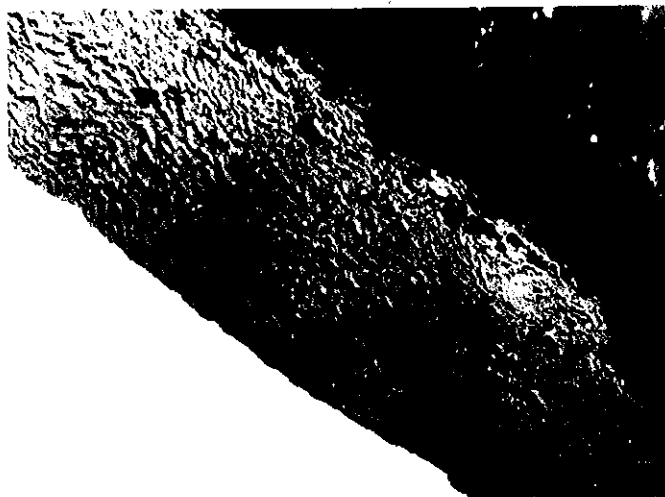
(d), (d)' Syntrol, 1 μ m alumina, 5 hours
(e), (e)' Syntrol, 1 μ m alumina, 8 hours
(f), (f)' Syntrol, 1 μ m alumina, 24 hours

Prolonged fine polishing (Figures 3(d) and 3(d)¹ to 3(i) and 3(i)¹) results in a gradual improvement in the resolution of well-defined features such as the edges, and vertical cracks. It seems reasonable therefore that the resolution of any fine cracks present would also improve.

The changing pattern of fine crack-like markings in Figure 3 is consistent with their being an intrinsic part of the oxide structure. While it could be argued that a structure such as Figure 3(h) or 3(h)¹ might be produced by the gradual loss of material from a layered structure which does not inherently contain cracks, it is equally likely that coarse grinding together with minimal fine polishing could obscure fine cracks which are actually present in the structure.

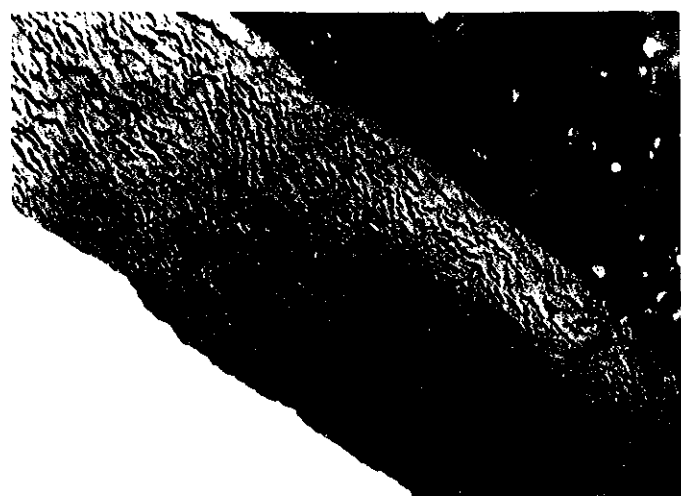
(g), (g)' Syntron, 1 μ m alumina, 96 hours
(h), (h)' Syntron, 1 μ m alumina, 188 hours
(i), (i)' Interferograms showing surface profiles
after 188 hours polishing

After re-grinding the specimen from its polished state (Figure 3(b)) using 600 grade SiC abrasive paper two areas were selected where the grinding directions were normal, and parallel to the metal oxide interface (Figures 3(a) and 3(a)¹). The changes in appearance of these two areas after Syntron polishing for 1, 3, 5, 8, 24, 96, and 188 hours, are illustrated in Figure 3(b) and 3(b)¹ to 3(h) and 3(h)¹. The interferograms corresponding to the final polished surface are shown in Figures 3(i) and 3(i)¹.

However, in other respects the appearance of the oxide cross sections are similar irrespective of the mounting technique. Lateral cracks are apparent, similar to those in the post-transition oxide in Zircaloy-2 (e.g. Figure 3(h)). The very irregular metal oxide interface is characteristic of this alloy and has been shown by Cowgill and Smeltzer (1967) to be associated with the different rates of oxidation of local regions of the alloy which contain different amounts of niobium in solution.

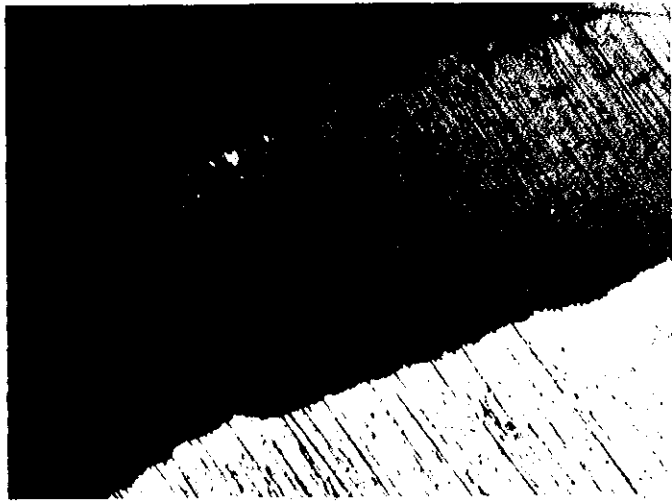
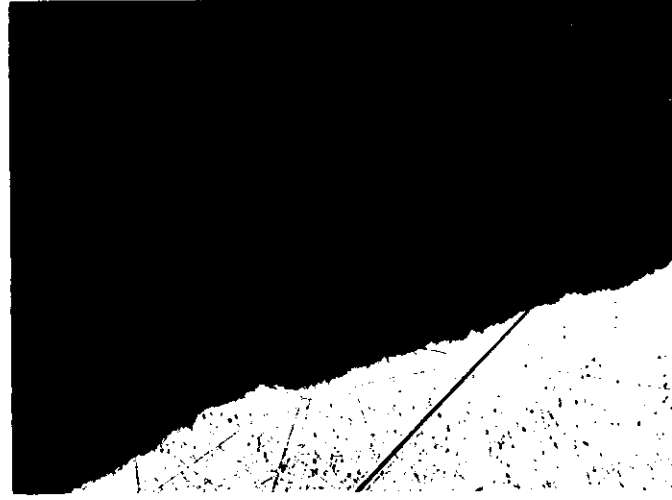
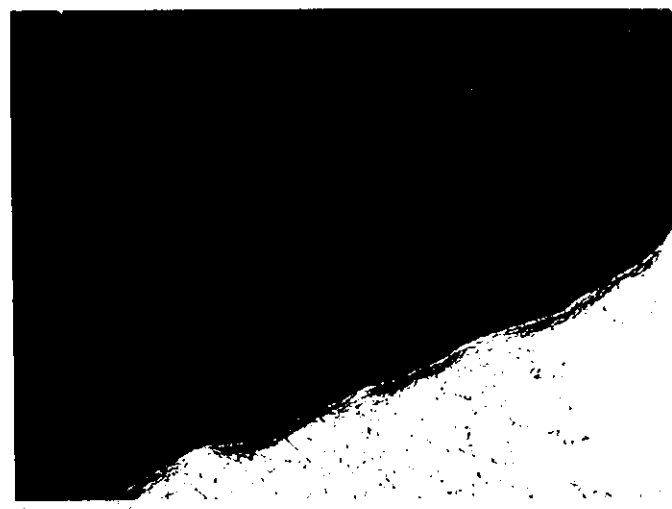
FIGURE 4 POST-TRANSITION OXIDE ON ZIRCALOY-2 REGROUND AND DIAMOND POLISHED
(Magnification 425 X)

Arrow # 1 shows coarsening of a vertical crack in the oxide
Arrow # 2 shows the apparent loss of a layer of oxide

- (a), (a)' after 2 minutes, 6 μ m diamond lap
- (b), (b)' after 5 minutes, 4-6 μ m diamond wheel
- (c), (c)' after 45 minutes, 4-6 μ m diamond wheel

Figure 4 shows how the appearance of the Zircaloy-2 sample changed when the re-ground surface was polished on a 6 μm diamond lap (Figures 4(a) and 4(a)¹) followed by polishing with 4-8 μm diamond abrasive on a polishing wheel for 5 and 45 minutes (Figures 4(b) and 4(b)¹, 4(c) and 4(c)¹). It is interesting to compare the changes in appearance with increasing time of polishing in Figure 4 with those in Figure 3. The diamond abrasive appears to remove more material from the surface, leading to the rounded type of markings which appear in dark contrast under the optical microscope. Similar markings can be seen on the sample in Figure 1(a), which had also been diamond polished during preparation. Figures 1(c) and 4(b)¹ have a very similar appearance.

The coarse vertical crack in Figures 4(a) to 4(c) (see arrow # 1) becomes progressively wider with increased time of polishing. The lateral markings which appear as cracks in Figures 4(a) and 4(a)¹ also broaden progressively to the point where whole layers of oxide appear to have been removed in Figure 4(c) and 4(c)¹ (arrows # 2). More oxide again has been lost from the surface for the series 4(a) to 4(c) where the initial direction of grinding was parallel to the metal oxide interface.

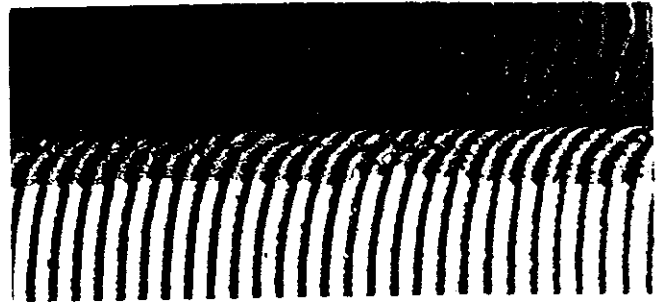
Vacuum impregnation with Araldite,

To evaluate the effect of the mounting technique, particularly the metal foil/bakelite method, a series of specimens of zirconium-2.5 wt.% niobium alloy, oxidised for various times in oxygen at 450°C, were mounted using methods (1), (2) and (4) (see section 2.3). Figure 5 shows identically polished sections of

a post-transition oxide from this series (164 mg dm^{-2}) together with interferograms showing the surface profiles obtained for each type of mount. The oxide mounted in nickel foil (Figure 5(e)) appears to have been firmly supported during polishing (pressure used during mounting was 28.9 MPa (4200 psi)). The interface between the foil and the oxide is sharp, and less rounding of the outer edge of the oxide is apparent in the interferogram (Figure 5(f)) than for the other mounting methods.

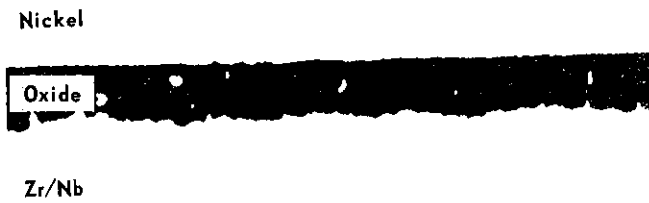
Bakelite/nickel foil, pressure mounted

FIGURE 5 POST-TRANSITION OXIDE ON ZIRCONIUM/2.5 WT.% NIOBIUM ALLOY (164 mg. dm^{-2})
 SHOWING THE EFFECT OF DIFFERENT MOUNTING TECHNIQUES ON THE APPEARANCE
 AND SURFACE PROFILES BY SYNTRON POLISHING
 (Magnification 425 X)

The results in Figure 5 show that the appearance of the oxide is not significantly influenced by the mounting technique. This conclusion is also supported by the fact that a similar appearance to that of the as-received oxide on Zircaloy-2 can be produced without the use of the bakelite/foil technique (compare Figures 1(c) and 4(b)¹). However, the relatively sharp oxide/mount interface in Figure 4(c) indicates that the foil technique has an advantage over the cold-mounting methods where accurate thickness measurements are required, or for the sectioning of very thin oxide layers.

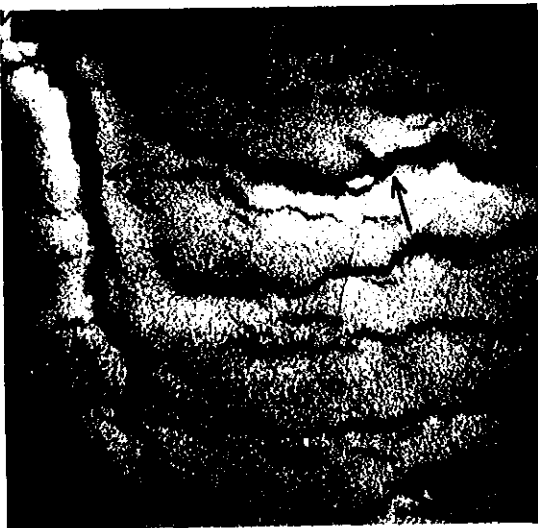
(b), (c) stereo pair showing area in the inset of Figure 6 (a) (scanning electron micrographs)
(Magnification 3800 X)

(magnification 68x) show how the specimen was bent, exposing the oxide in cross section. Figures 7(c) and 7(d) (magnification 680x) show how the cracks in the oxide are predominantly parallel to the metal oxide interface at the corner of the specimen. Figure 7(e) and 7(f), a stereo pair (magnification 204x) show an adjacent area of oxide to the left of that shown in 7(c). It is interesting to note that the shape and spacing of the cracks in this stereo view are very similar to those which appear after Syntron polishing, such as in Figure 3(h) or in Figures 6(b) and 6(c).

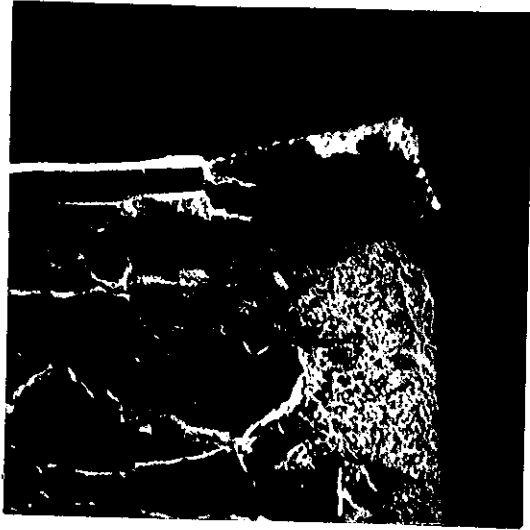
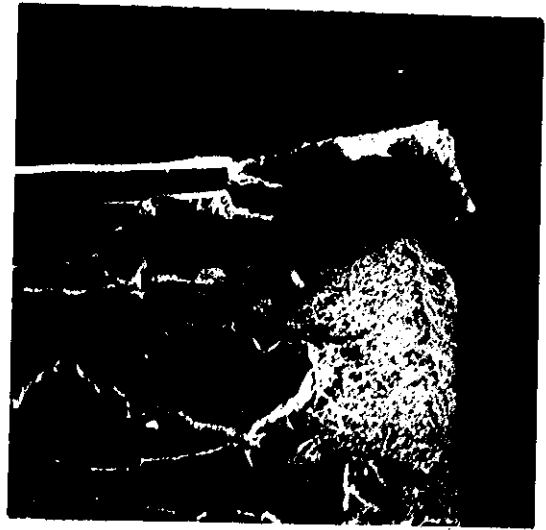
(a), (b) stereo pair showing how fracture surfaces were obtained by bending the specimen
(Magnification 68 X)

The corresponding fracture surfaces as seen in the scanning electron microscope are shown in Figures 7 and 8. Figures 7(a) and 7(b), a stereo pair
