AUSTRALIAN ATOMIC ENERGY COMMISSION
RESEARCH ESTABLISHMENT
LUCAS HEIGHTS

ACOUSTIC EMISSION MONITORING OF A STEEL BIFURCATE
AT DARTMOUTH DAM

February 1978

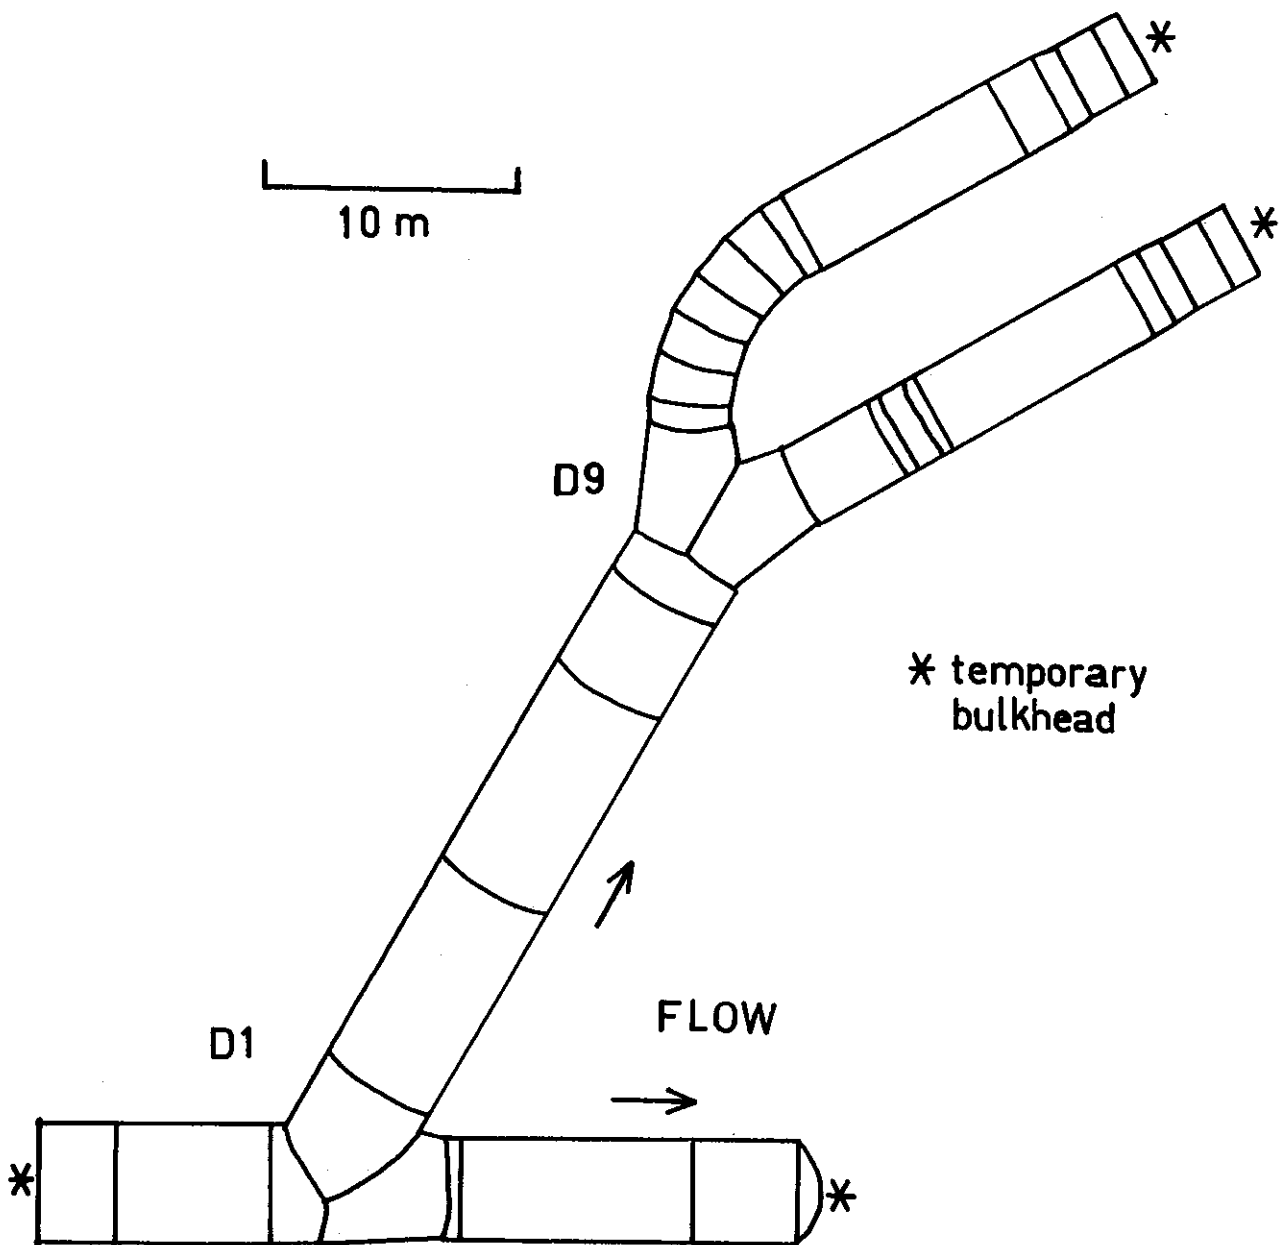
FIGURE 1. OVERALL PLAN OF THE DARTMOUTH DAM OUTLET.
BIFURCATE D9 WAS TESTED FOR ACOUSTIC EMISSION

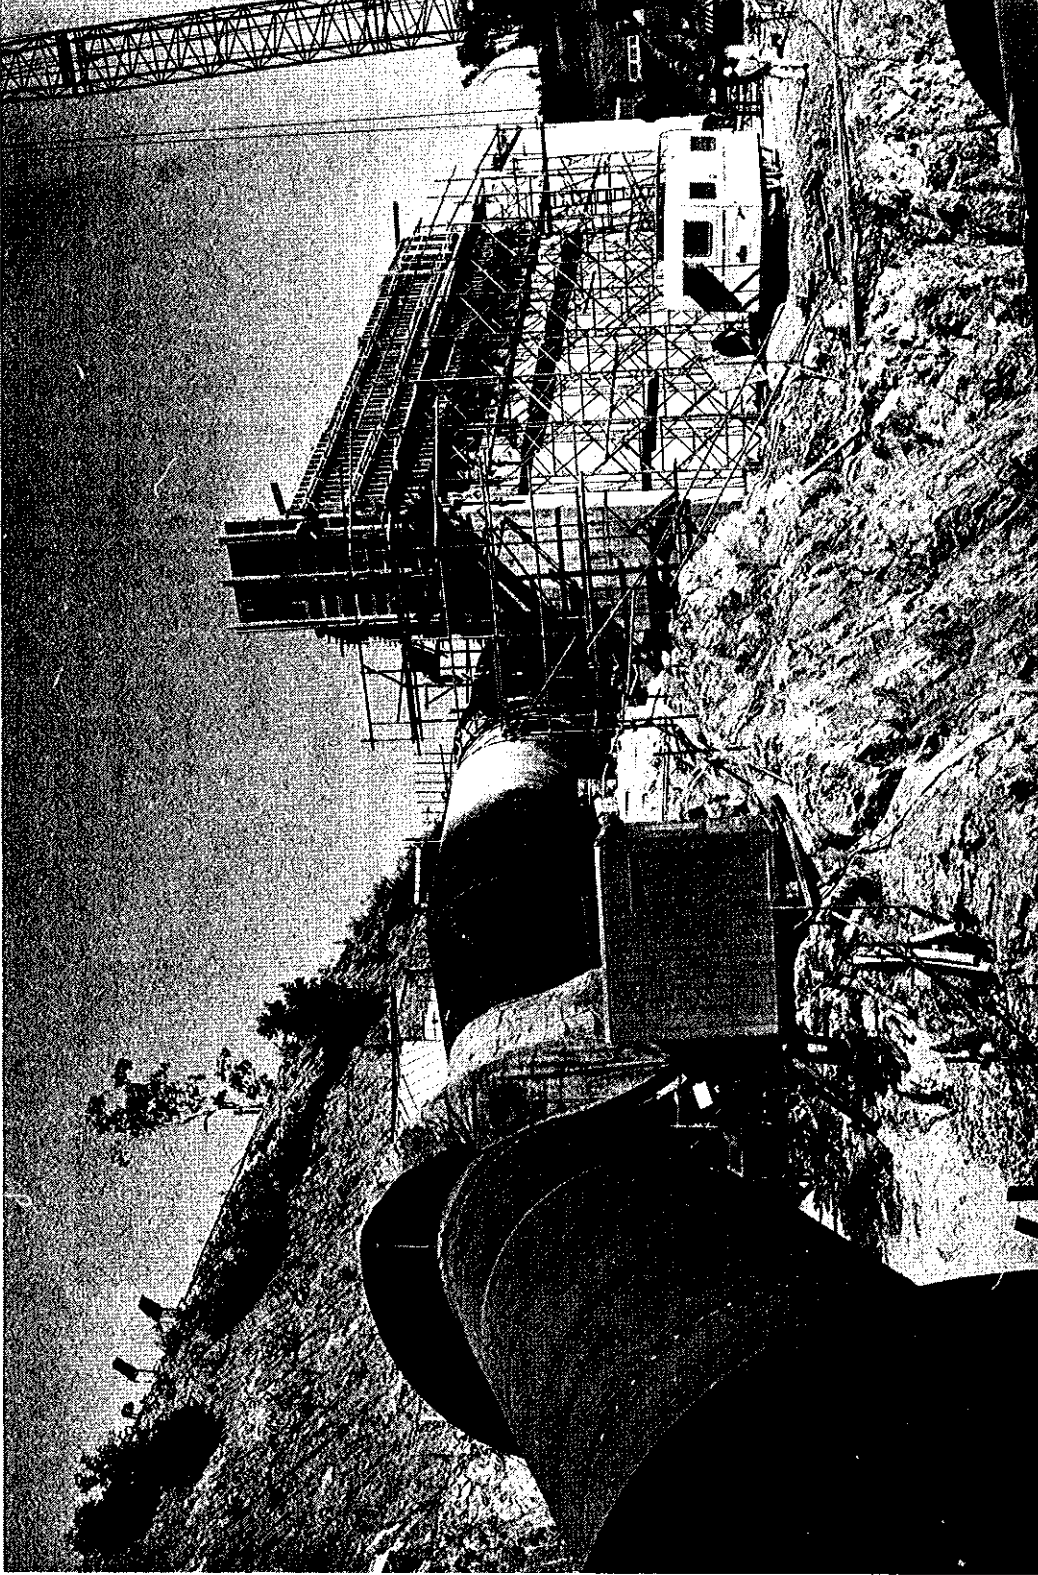
FIGURE 3. TEST LOCATION SHOWING THE AEC MOBILE ACOUSTIC EMISSION LABORATORY IN POSITION. The D9 bifurcate is on the left of the picture. The SMEC strain gauging equipment was located in the hut adjacent to D9.

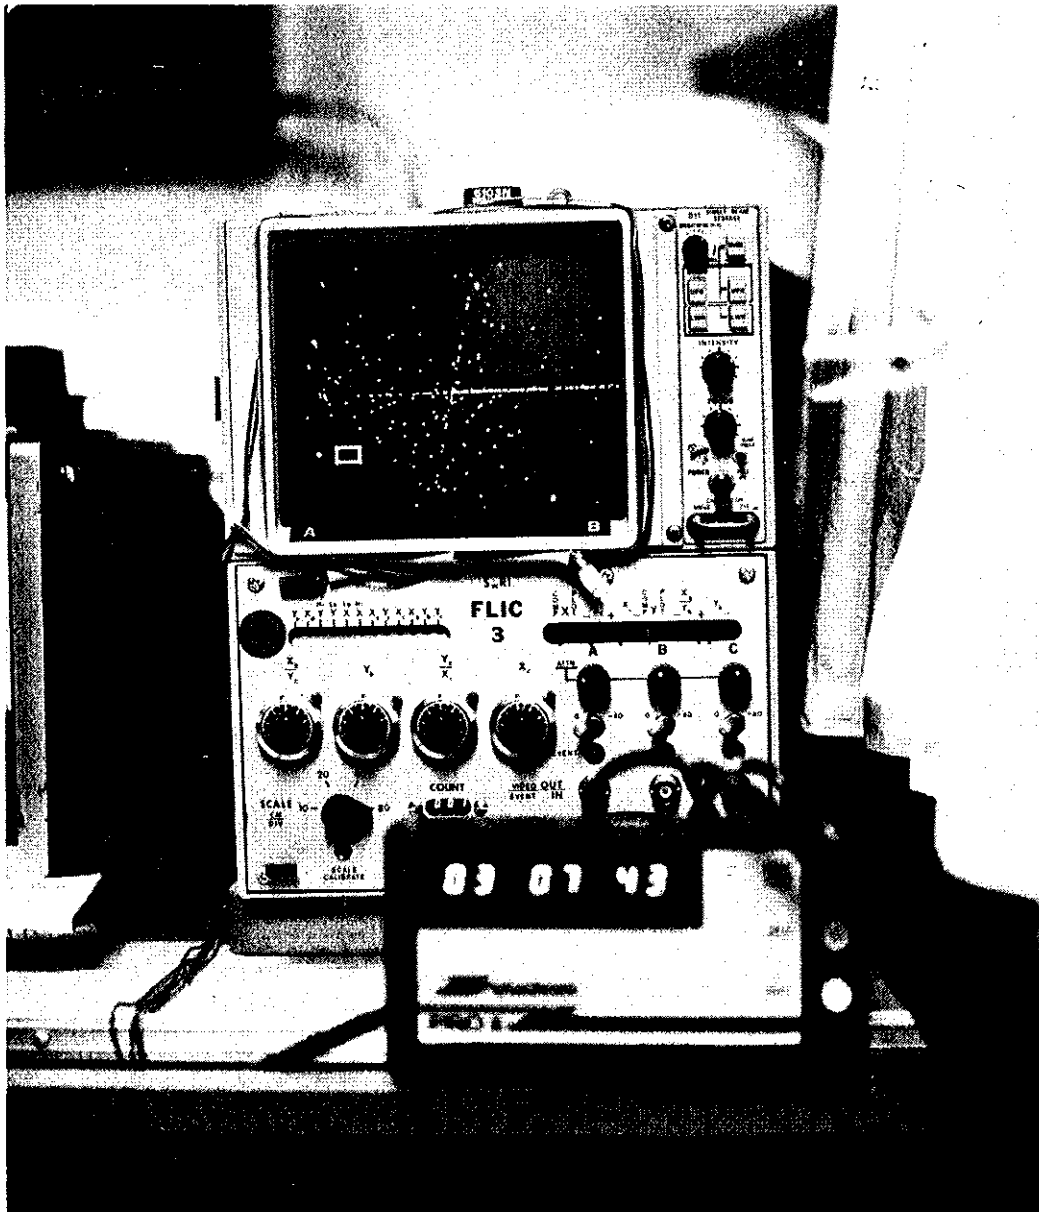
The AAEC has recently obtained a flaw location computer (FLIC 3) from Southwest Research Institute, San Antonio, USA (Figure 4). This is an analogue device which monitors the output of three transducers, calculates the origin of AE bursts, and displays the location of the source as a stored spot on a storage oscilloscope. The unit, which works in real time, is suitable for field work such as the Dartmouth Dam test.

FIGURE 4. THE FLAW LOCATION AND IMAGING COMPUTER, (FLIC 3.) USED FOR LOCATING SOURCES OF ACOUSTIC EMISSION ON D9.
