**AUSTRALIAN ATOMIC ENERGY COMMISSION  
RESEARCH ESTABLISHMENT  
LUCAS HEIGHTS**

**ACOUSTIC EMISSION MONITORING OF A STEAM  
RECEIVER PRESSURISED TO FAILURE**

April 1978

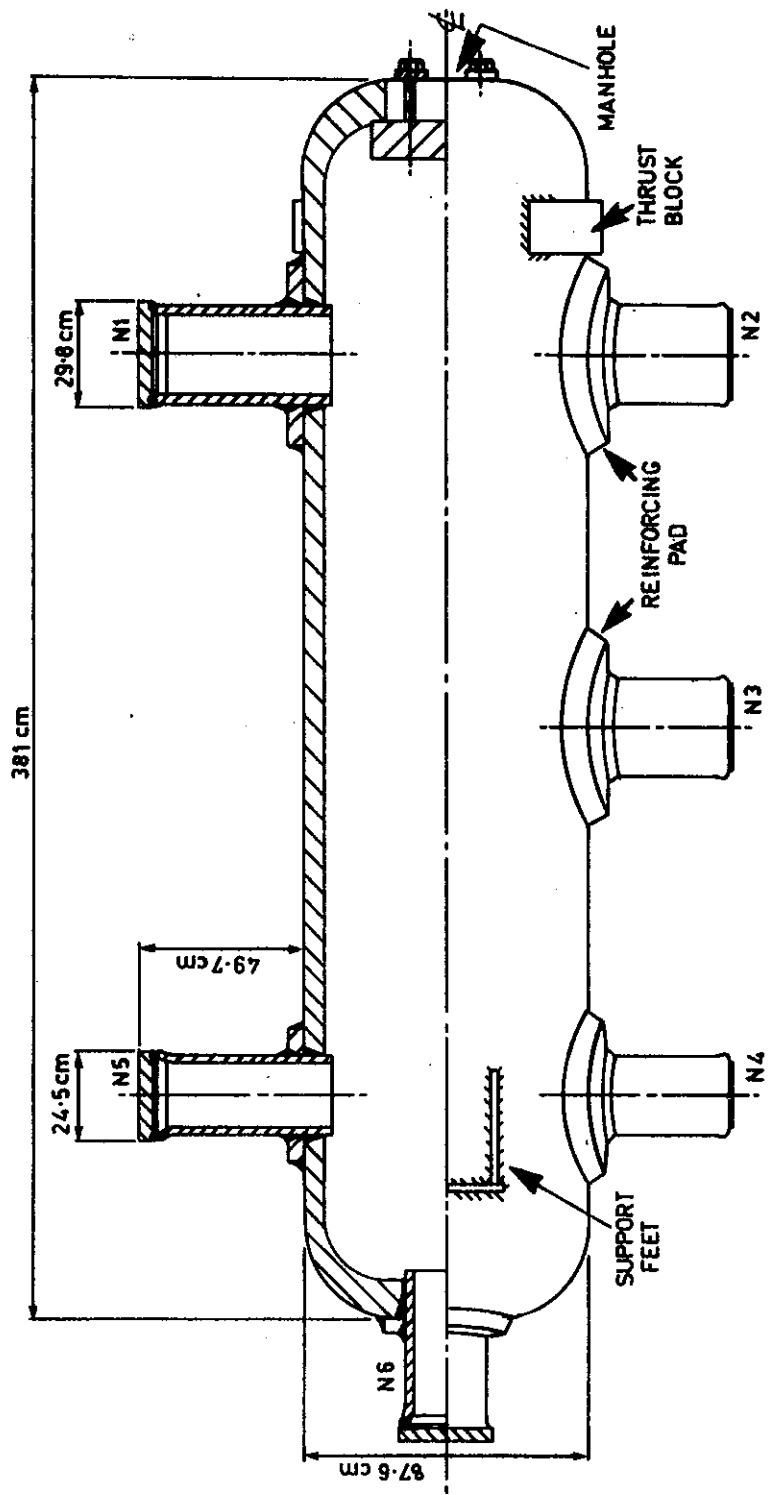
Figure 1 Drawing of pressure vessel

The pressure vessel was made in England from forged Cr-Mo steel. The 3.65 m long cylindrical body was 60 mm thick and penetrated by five nozzles which were placed three on one side and two on the other; the nozzles were fabricated in Australia. In service these nozzles were connected to external pipework but, for the test program, they were blanked off by welded plates. An access port was already present in one of the hemispherical ends. Figure 1 is a drawing of the vessel and Figure 2 is a fisheye photograph of the vessel in the testing bunker.

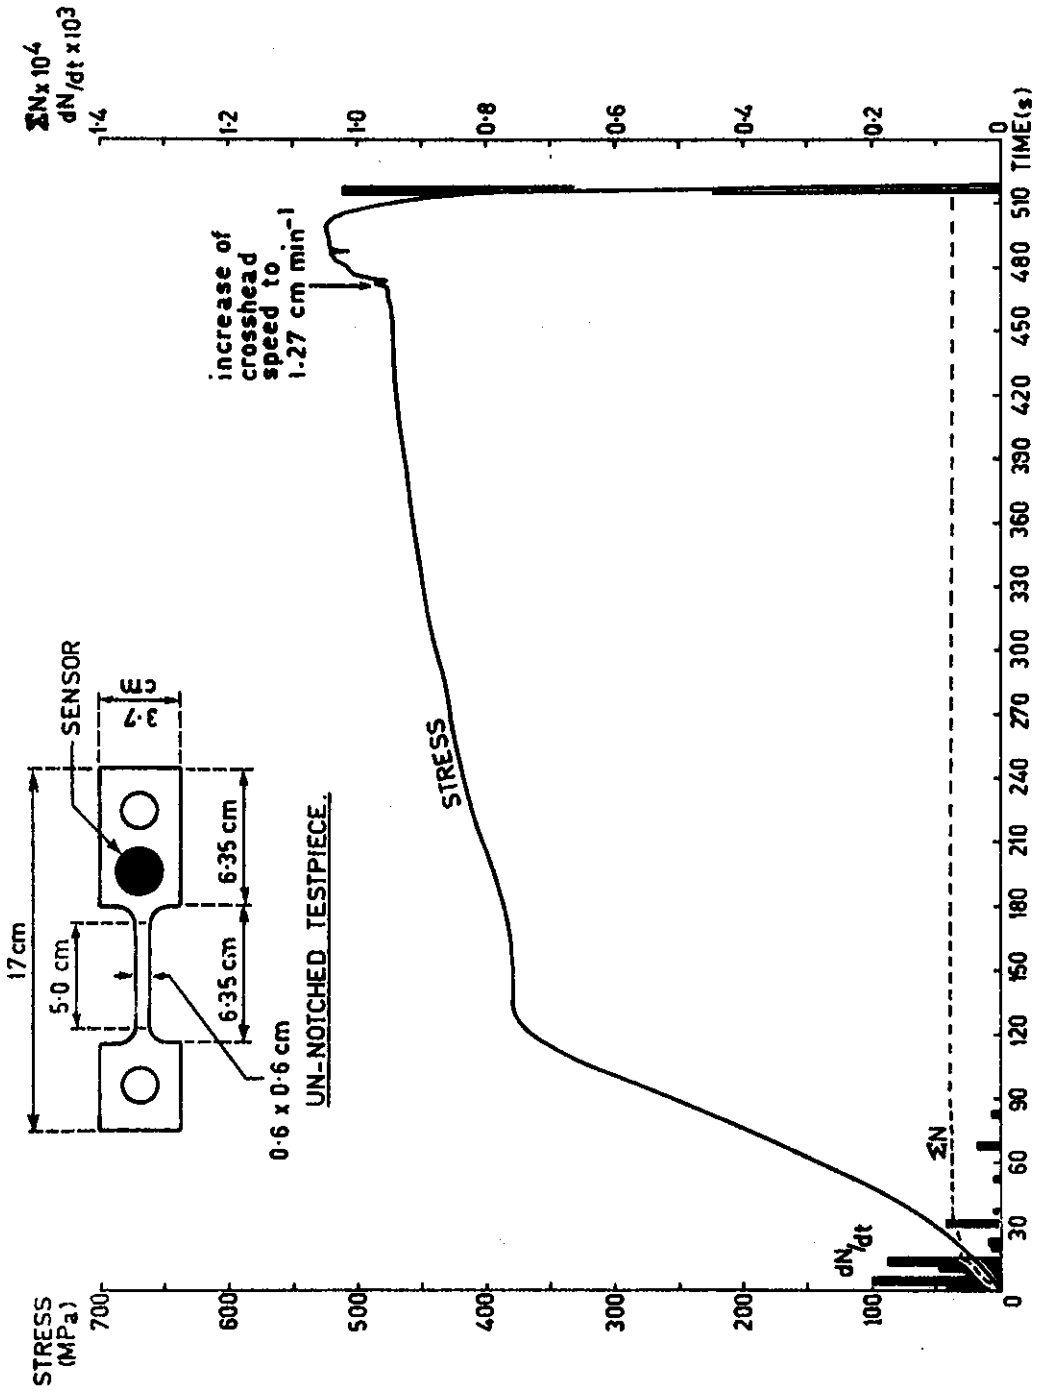
When using AE techniques, it must be recognised that, in general, emission will be produced only when the test stress or pressure exceeds any previous value; this memory phenomenon is known as the Kaiser effect [Kaiser 1950]. A further problem is that some materials which deform primarily by a ductile process may produce little burst-like emission [Birchon 1976]. In particular, many clean high-quality steels, similar to those used for fabricating the AWRA pressure vessel, are relatively quiet (in an AE sense) and will produce useful emission only during yielding. After yielding, the material may flow plastically with very little AE; this is shown in the data of Figure 3, which represents the acoustic emission during the tensile testing of a sample of a similar Cr-Mo steel.

Figure 3 Acoustic emission behaviour of a tensile test sample of steel similar to that used in the vessel. (Note that most activity occurs during yielding.)

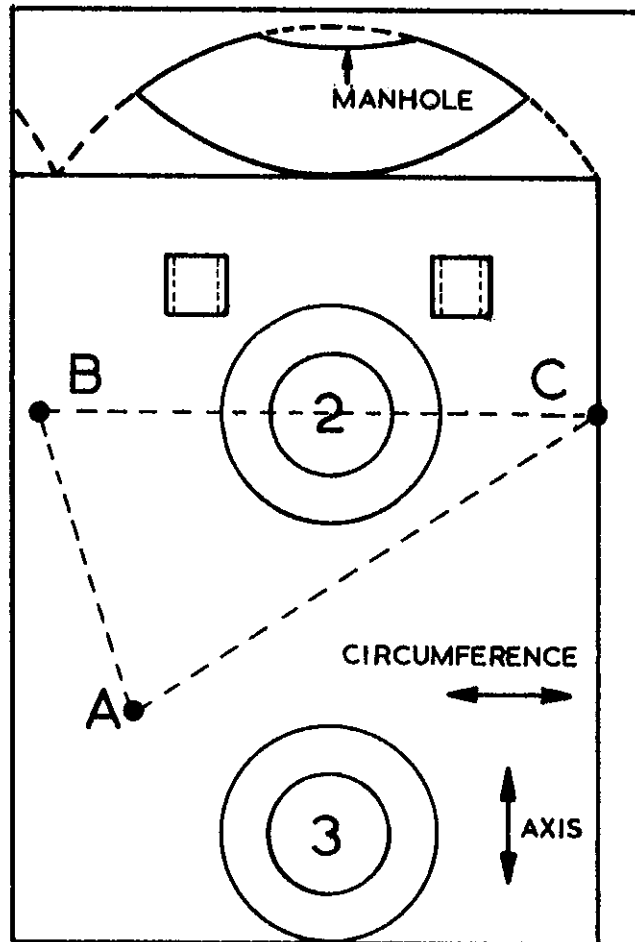
FLIC unit to give the spatial map of AE activity. The positions of these are shown in Figure 4. Specifically the geometric arrangement of the sensors was designed to monitor nozzle 2, as ultrasonic testing conducted after early pressure cycles indicated that some growth of existing cracks had occurred adjacent to this nozzle [Woodward *et al.* 1976]. However, the area monitored was significantly larger (approximately 1.0 x 1.5 metres) and included portion of nozzle 3.

Figure 4 Positioning of the transducers used for source location.  
(These are in the vicinity of nozzles 2 and 3. The transducers are identified A, B and C.)

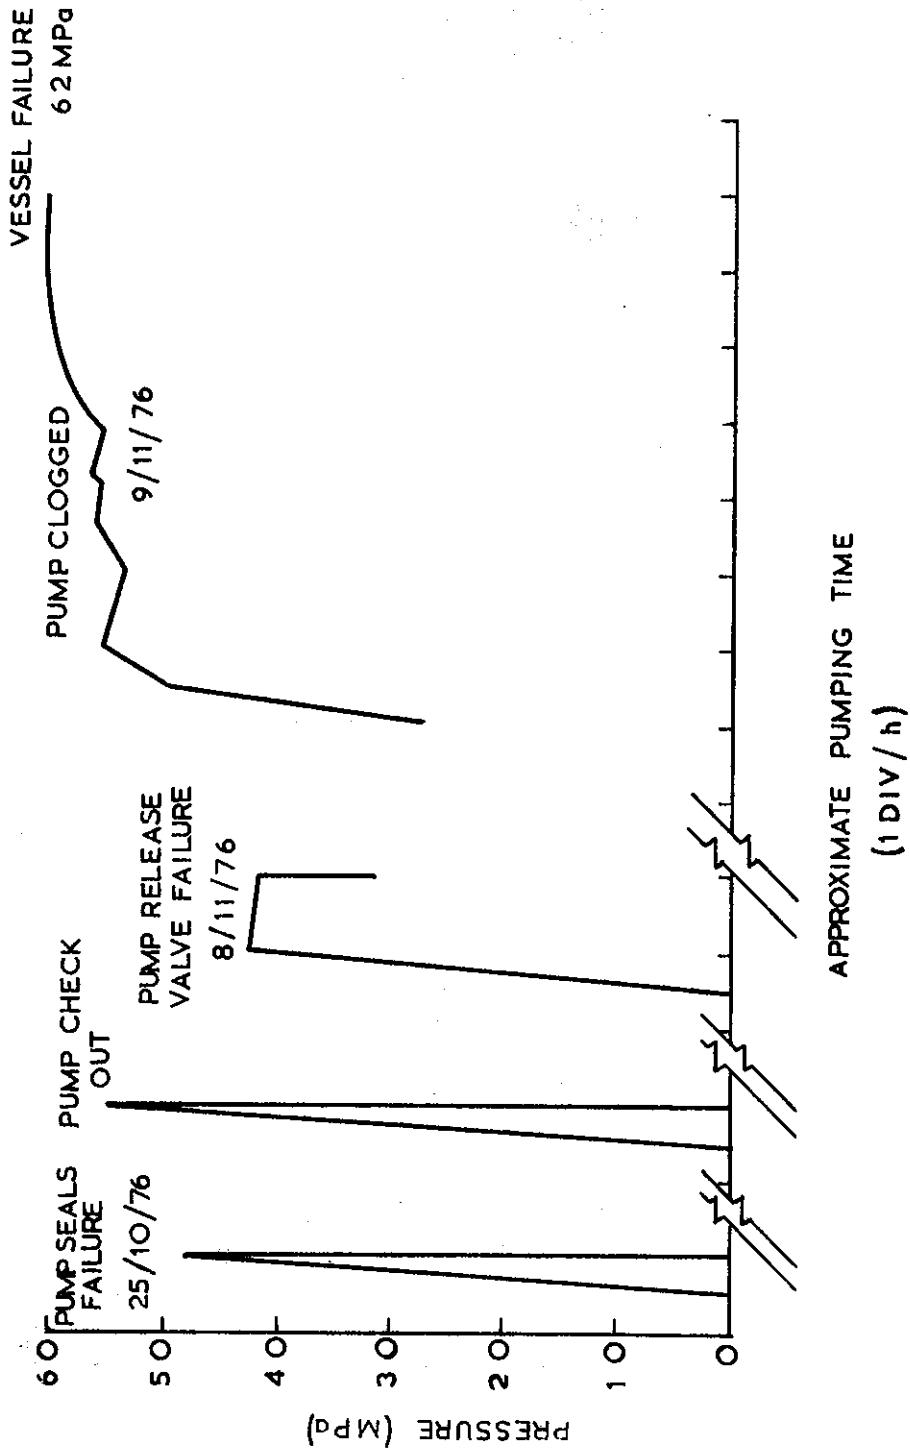
Figure 7 Time history of final pressurisation cycles.

The time history of the final four cycles is given in Figure 7. As the pressurising pump was near the limit of its performance, there were breaks in the program to allow pump repairs to be carried out. A great deal of AE in the vessel was evident during all pressurisation cycles, but much more arose from such phenomena as the motion of the vessel on its supports and the bedding of the manhole cover on its seal. Much of this activity produced artefacts within the monitored triangular area. Artefacts are apparent activity within the monitored area which result from AE events which are well outside the area. Most artefacts are easily recognised as they appear as straight lines emanating from the centroid of the triangle defined by the FLIC sensors. Figure 8 is an annotated reproduction of the FLIC display, and the artefacts are indicated.
